**ITEM:** 908 Rex Street Landmark/ Historic Preservation Fund  
Grant/Alteration Certificate Request

**REQUEST:** The applicant requests to Landmark the structure at 908  
Rex Street and a request for a Preservation and  
Restoration Grant and Alteration Certificate at 908 Rex  
Street.

# HISTORIC STRUCTURAL ASSESSMENT

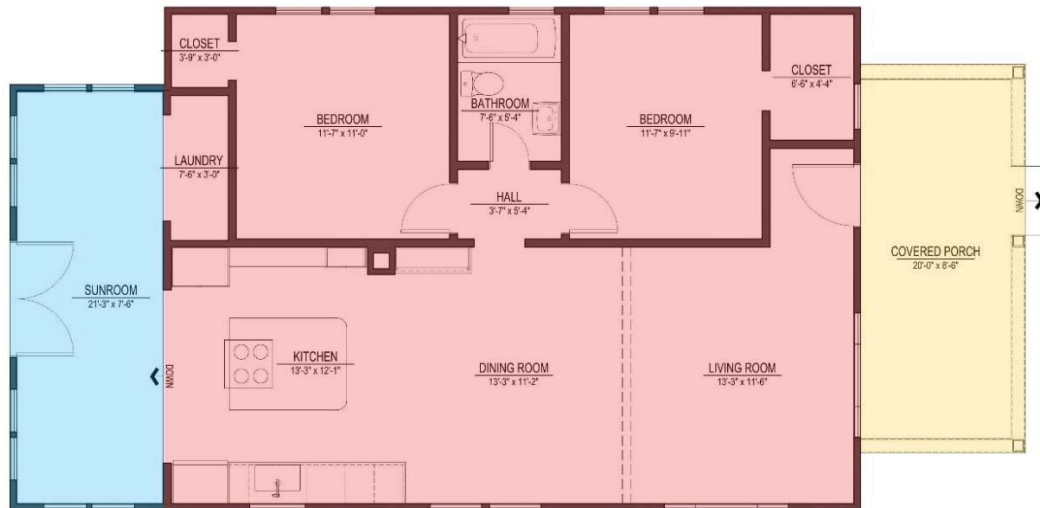
The footprint of the original house is shown in red as determined by observations made in the basement and attic. The yellow area is the original covered porch at the front of the house facing Rex Street. The blue area is a rear addition that was originally a patio and was later enclosed and made part of the living structure. The chimney and basement were likely added to accommodate a coal-fired heating system. All of these changes were complete at the time of the county assessor documentation in 1948.

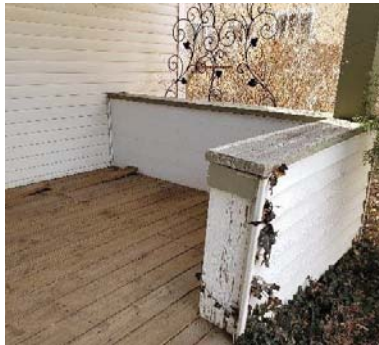
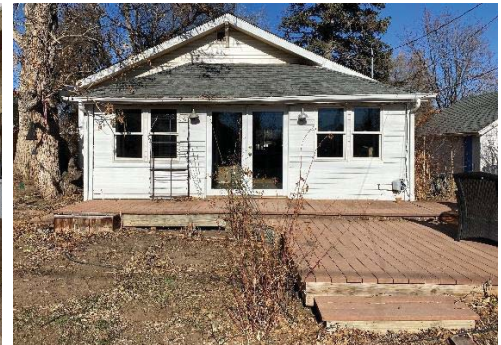
The covered front porch rests on a poured concrete foundation that is original and was poured at the same time as the original building foundation. Other than the exposed foundation, the remainder of the porch structure could not be inspected as it is all wood-wrapped. The porch structure is likely wood construction and original. The condition of the porch structure could be further assessed by the removal of finishes and decking.

1. Remove front porch decking, siding, and wrapping materials to further inspect the structural elements.
  - a. Restore and/or replace any structural elements found to be failing.
2. Remove front porch decking and replace with a composite decking to match.
3. Remove all siding and wood-wrap and replace and paint with similar original materials.
4. Restore, refinish, and/or replace rear deck.

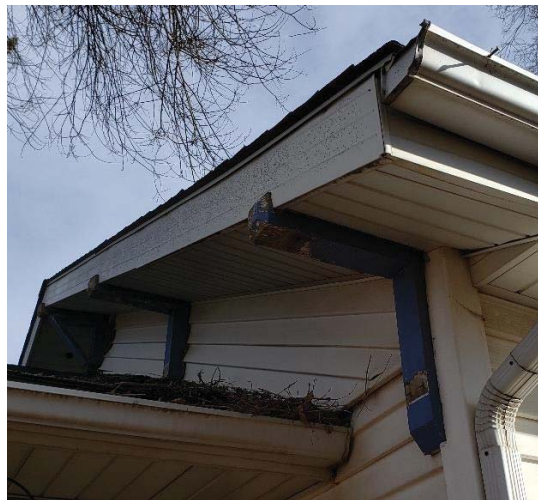
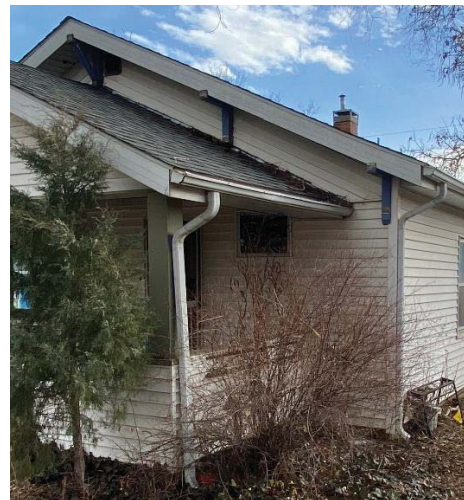
Most of the soffits are vinyl soffit panels that are in fair condition. The soffits on the rear gable end of the original structure is unpainted soffit board. There are areas of soffit transitions that are of poor construction that are failing and could lead to future problems. There is no evidence as to what the original soffits were. Removal of the vinyl soffits along with removal of the vinyl siding could lead to clues as to the original soffit construction.
