## HISTORIC STRUCTURAL ASSESSMENT 809 MAIN STREET, LOUISVILLE, COLORADO

12/18/2018

## INTRODUCTION

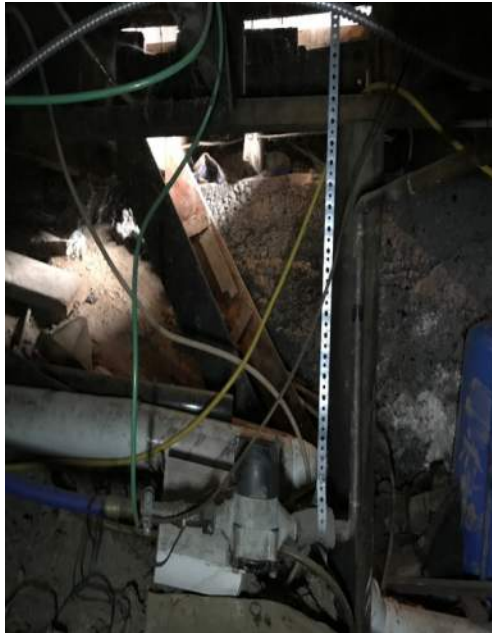
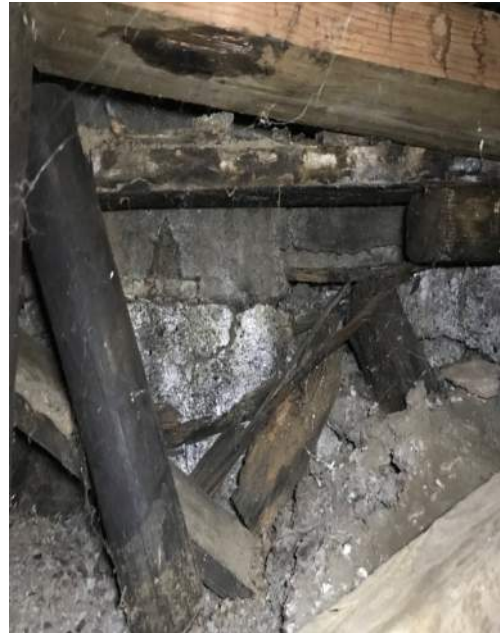
Significantly, much of the visible foundation is deteriorating due to poor construction methods compounded by flooding and water infiltration over the years. The crawlspace is a dug-out

Foundation at crawlspace entry

Recommendations: The foundation is not likely reinforced and has experienced movement or may never have been level in the first place as evidenced by uneven floors and walls. It is anticipated that unless the foundation is adequately reinforced, it will continue to perform in this way and likely worsen. The building foundation should be replaced on the north and south sides of the building at a minimum, and careful consideration should be given to reinforce or rebuild the east foundation wall under the storefront façade along Main Street.

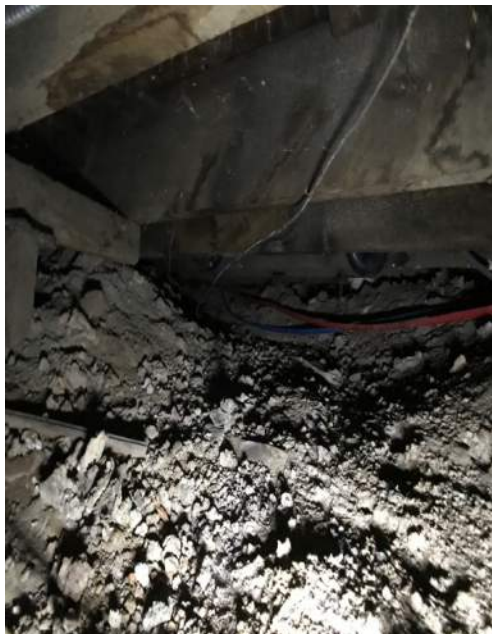
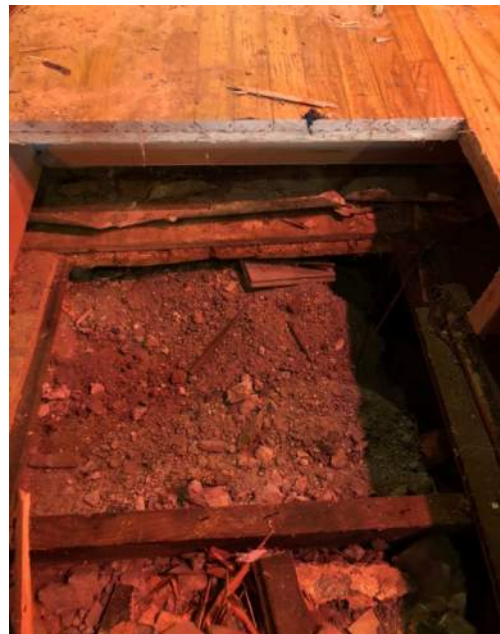
Foundation towards west (rear) of building

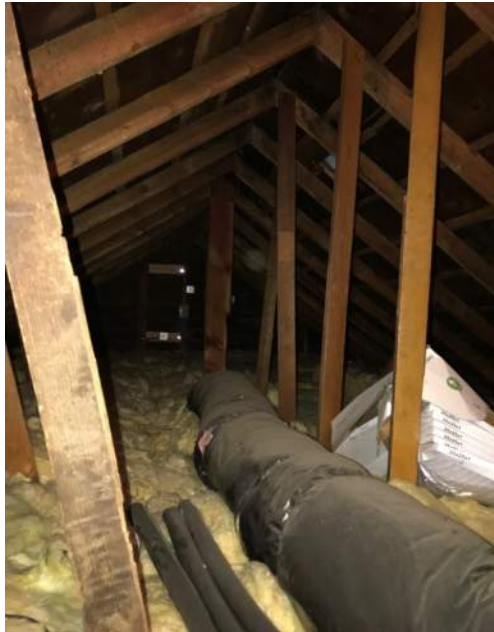
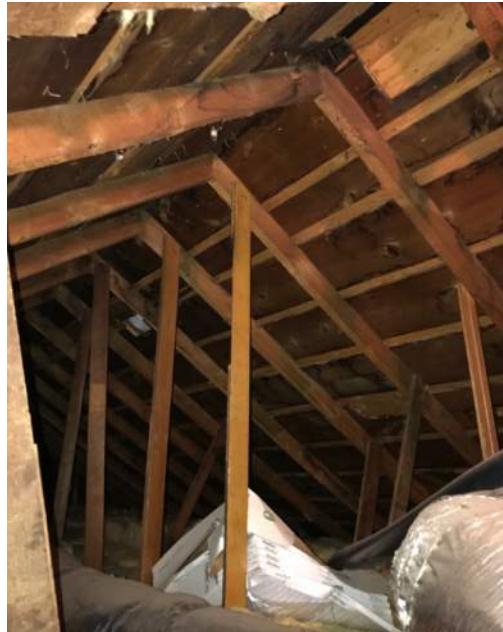
The roof framing is of cut wood rafters (~2x4's) spaced in excess of 24" centers. ¾" thick boards span over the roof rafters with gaps in between them (commonly called "skip sheathing"). Plywood sheathing was installed over the top of the skip sheathing during a more recent roofing replacement effort. 2x kickers were installed spuratically from the roof rafter to the ceiling rafters.

Attic with roof framing

Recommendations: The roof framing appears to be performing adequately although the structural system, particularly the zone supporting the air handling unit, should be analyzed and reinforced as a part of any future structural work. There is no lateral force resisting system in the structure. Lateral forces from wind or seismic events must be addressed in future structural improvements. In order to support the work required to repair/replace the existing foundation, the roof will need to be reinforced, repaired and/or replaced prior to work on the foundation and floor system.

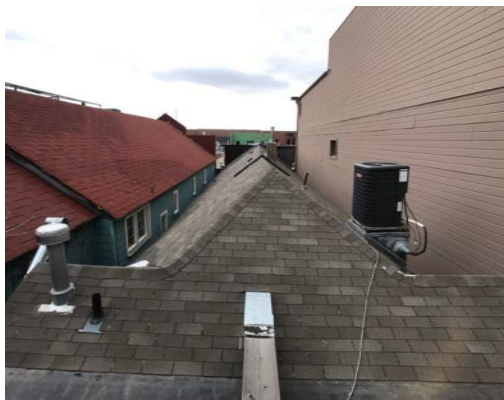
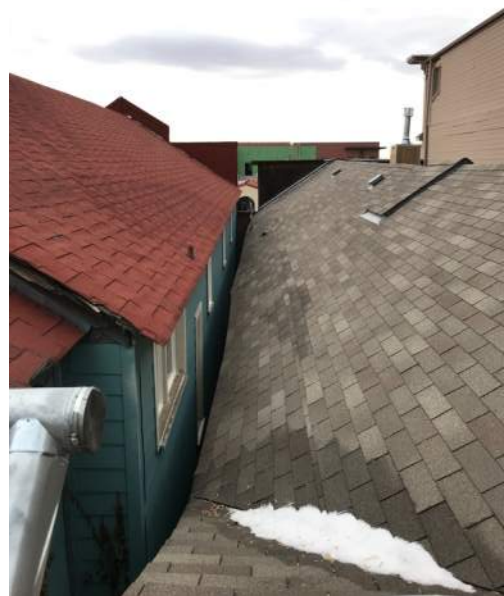
The main portion of the building's roofing is a 3-tab asphalt composite shingle (circa mid-late 1980's) and covers the gable and hip pitched roof areas with shingled valleys. The asphalt shingles are thin and show accumulated hail damage from years of weather exposure.

Asphalt shingles

Recommendations: The asphalt shingles should be replaced and step flashing should be installed at the east storefront wall and new flashing should be installed along the roof edges. There are multiple penetrations in the membrane roof and a number of pieces of mechanical equipment located on the low-pitched roof. The membrane roof should be inspected by a roofing contractor for hail damage and leaks.

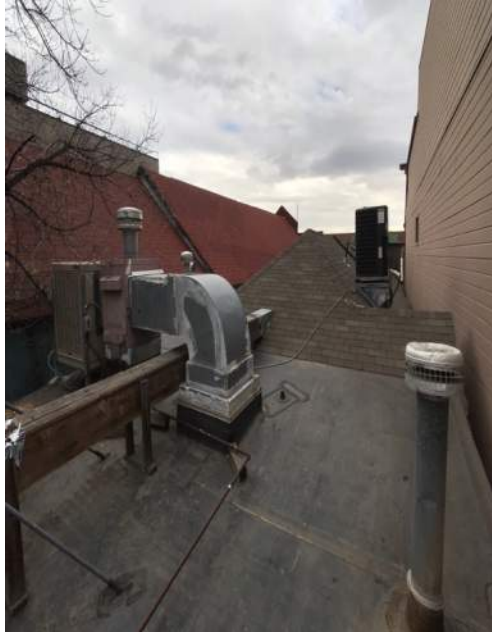
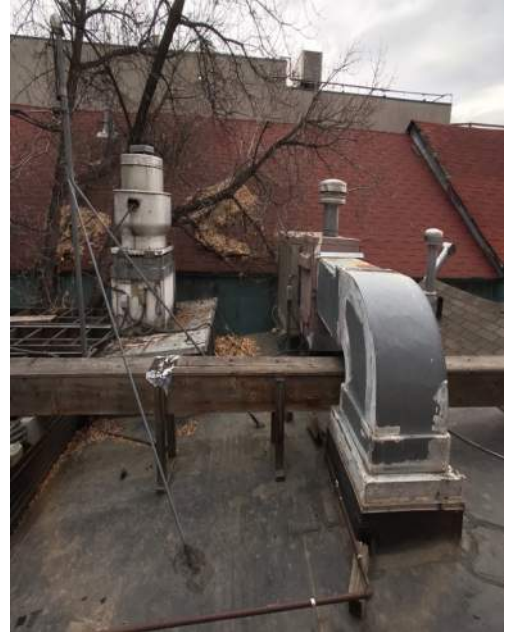
The low pitched roof toward the rear, western portion of the building over the kitchen area is a black rubber-type sheet membrane similar to an EPDM material. The membrane roof appears to be in decent condition and is newer than the other existing roofing. All penetrations are sealed with the membrane roof material.

Membrane roof with penetrations

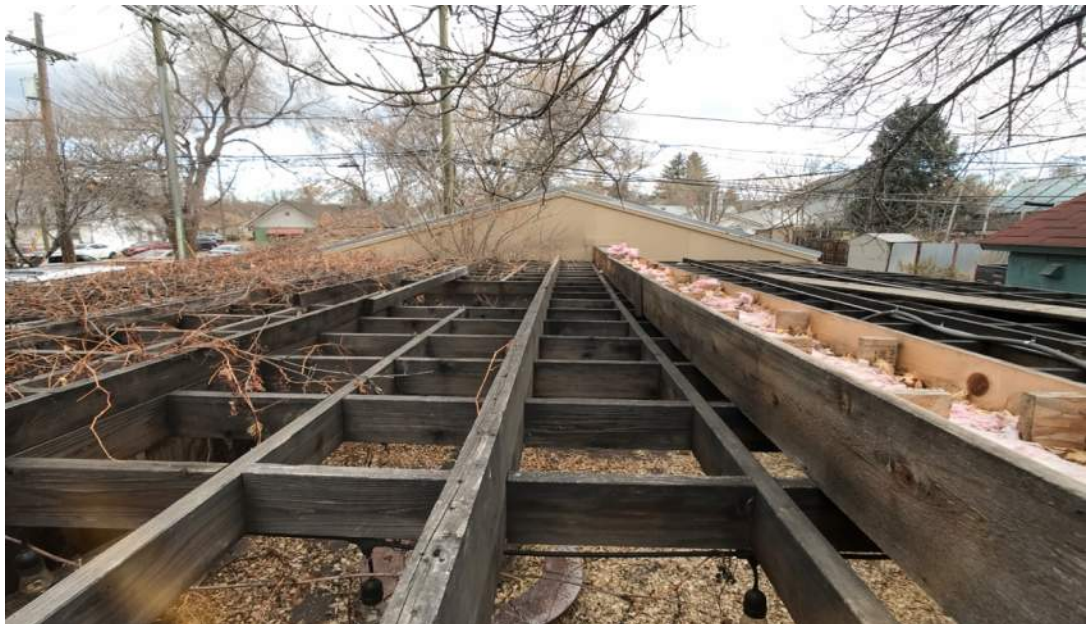
To the west, the building has a paver patio with a paver ramp leading toward the alley. The patio is covered by an open wood trellis structure. The pavers and paver surface is generally in good shape. The ramp provides the only means of access and egress to the building for occupants. The wood trellis appears to be in good condition despite natural weathering due to being unfinished.

Trellis detail over patio from above

Recommendations include: Pavers should be further inspected for compliance with adopted building codes for accessibility. A handrail should be installed at the ramp and the pathway and door design should be further studied to comply with accessibility.

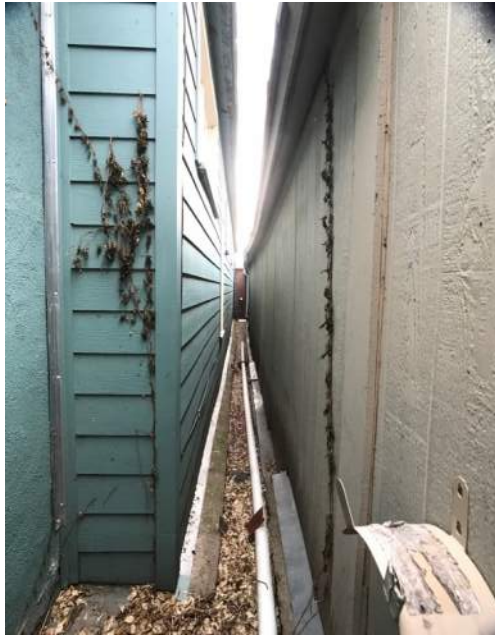
The wall studs are of sufficient size to carry the exterior loads, but it should be anticipated that some studs are likely suffering from wood rot at their bases. Both the north and the south walls are wavy, presumably due to the roof pushing outward on the top of the walls, giving the appearance of an undulating surface. It is also surmised that the building was constructed in variatious iterations from east to west, and at assumed addition locations the walls seem to be particularly out of plumb.

Detail of north exterior wall

Recommendations: Distressed wall studs should be identified and repaired as part of any future structural work. There is no lateral force resisting system in the structure. Lateral forces from natural events must be addressed in future structural improvements. Recommendations for repairs and reinforcing to the roof structure is covered under the Roof Construction section of this document.

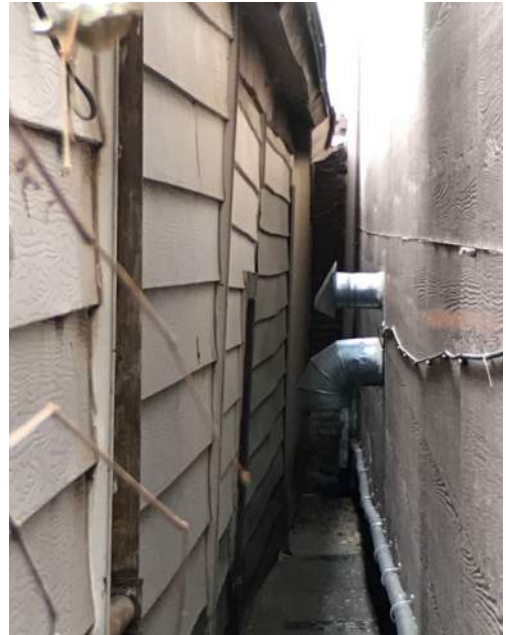
Detail of south exterior wall

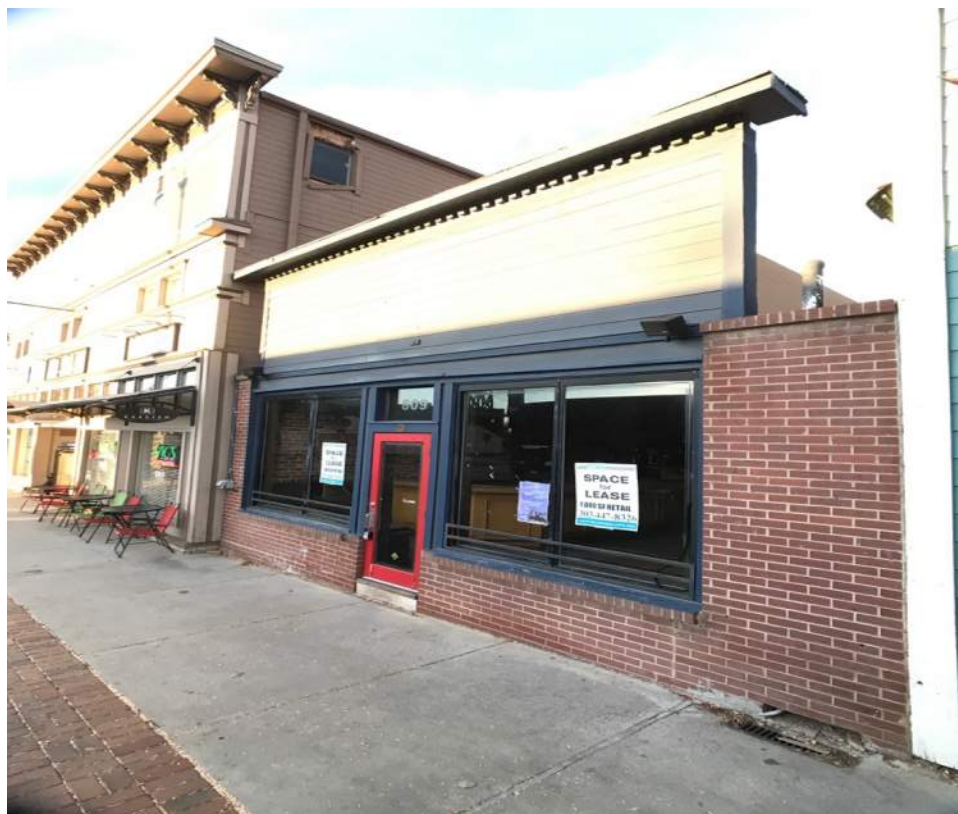
The wall structure appears to be in good condition. The lap siding appears to be the original building siding and shows normal wear-and-tear for a building of this age. The back side of the storefront wall is clad in painted plywood siding and shows signs of distress and peeling paint. The brick veneer has significant cracks in multiple locations.

Storefront façade

Recommendations include: The wood siding should be repaired or replaced depending on the condition and location on the wall and properly sealed at all edges. The back side of the wall should be replaced with a similar and more durable product (i.e. painted cement board) with proper sealing. The brick veneer is not original to the building and should be removed as a part of the landmarking process and restored to its original condition based on historical photos.

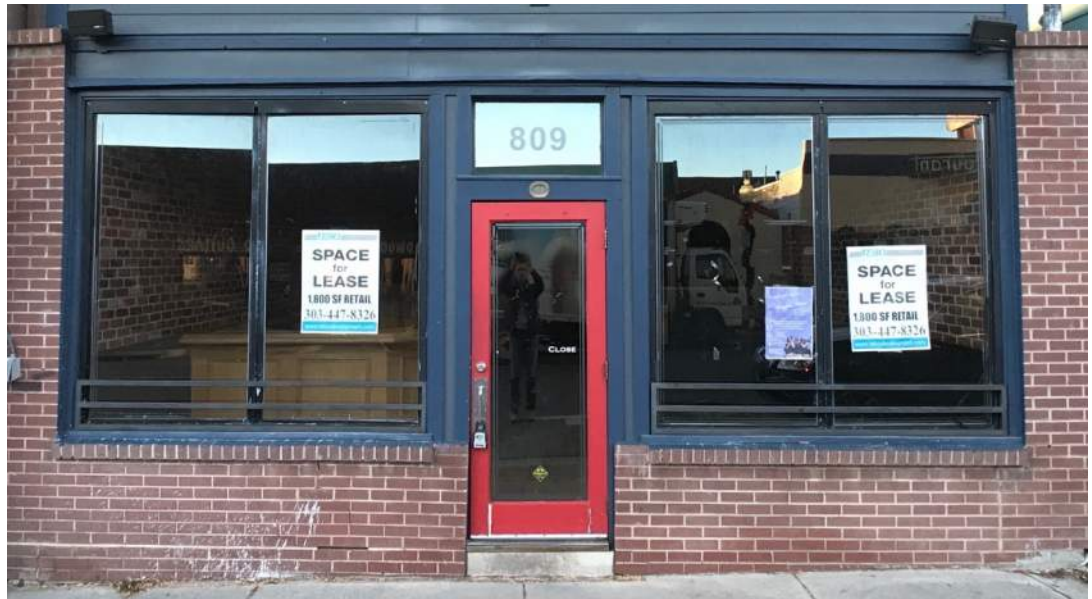
The windows at 809 Main are constructed from welded steel frames and single-pane glass. Window units are constructed to bi-fold open to the interior and side walls of the building. The windows do not contain any weatherstripping and display gaps between sashes allowing air infiltration.

The painted front door is wood with D-pull style hardware. The rear door is a painted wood half-lite double door. Both doors are showing deterioration due to use. Gaps are forming between the stile and rails on each door. The painted surfaces are cracked and peeling. The weatherstripping is not adequate on either door. The doors both swing over a step up threshold and are not code compliant.

Exterior window and door detail

Recommendations include: Replace windows with historic replications.

Recommendations include: Replace both doors, including hardware, thresholds and weatherstripping.

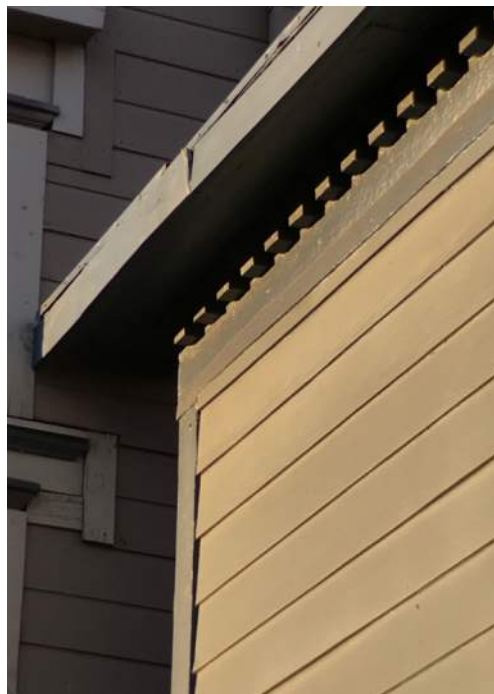
The cornice is constructed of 2x framing material and overhangs the front and sides of the storefront façade wall. The fascia is 1x6 square profile, painted wood. The soffit is a painted plywood material. The cornice is uneven and sagging due to poor construction techniques. The cornice appears to have inadequate roofing or no roofing material on top of the flat portion and there is no drip edge flashing around the perimeter. The cornice slopes toward the front of the storefront wall in some locations. The fascia is in varying states of deterioration and needs to be scraped, repaired and refinished.

South façade cornice detail

Recommendations: Reinforce or rebuild the cornice to be adequately supported and sloped toward the rear. Install appropriate flashing and roofing over the top of the cornice. Scrape the existing paint on the fascia and decorative trim to bare wood where possible, repair the wood and refinish with appropriate sealing around the edges. Replace the plywood soffit.

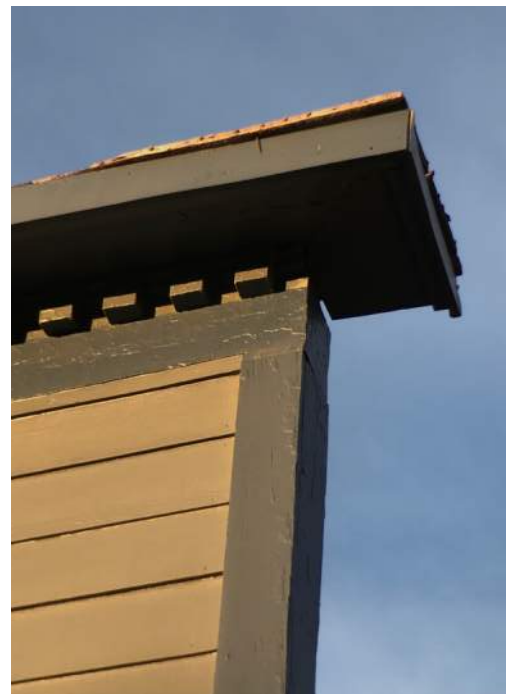
North façade cornice detail

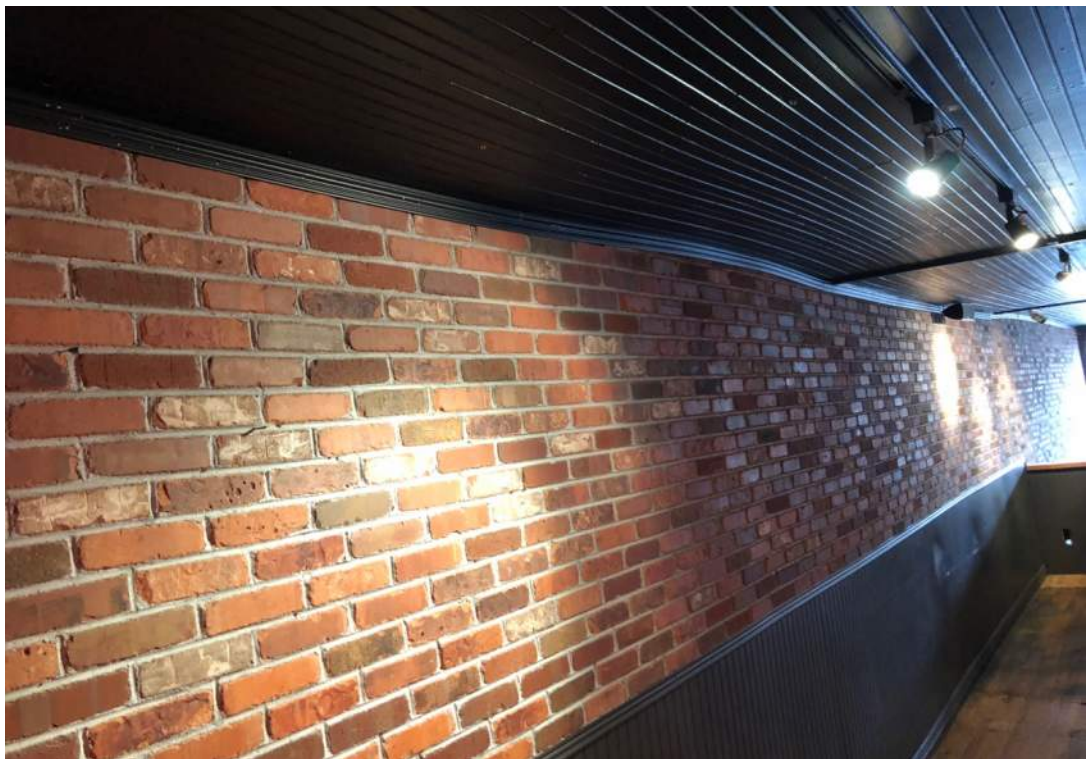
Detail of wall movement
