**SUBJECT:** RESOLUTION NO. 30, SERIES 2023 – A RESOLUTION APPROVING A PRESERVATION AND RESTORATION GRANT FOR THE COLACCI HOUSE AT 1209 MAIN STREET

# 1209 Main Street

## Historic Structure Assessment

#### 3.0 Condition Assessment

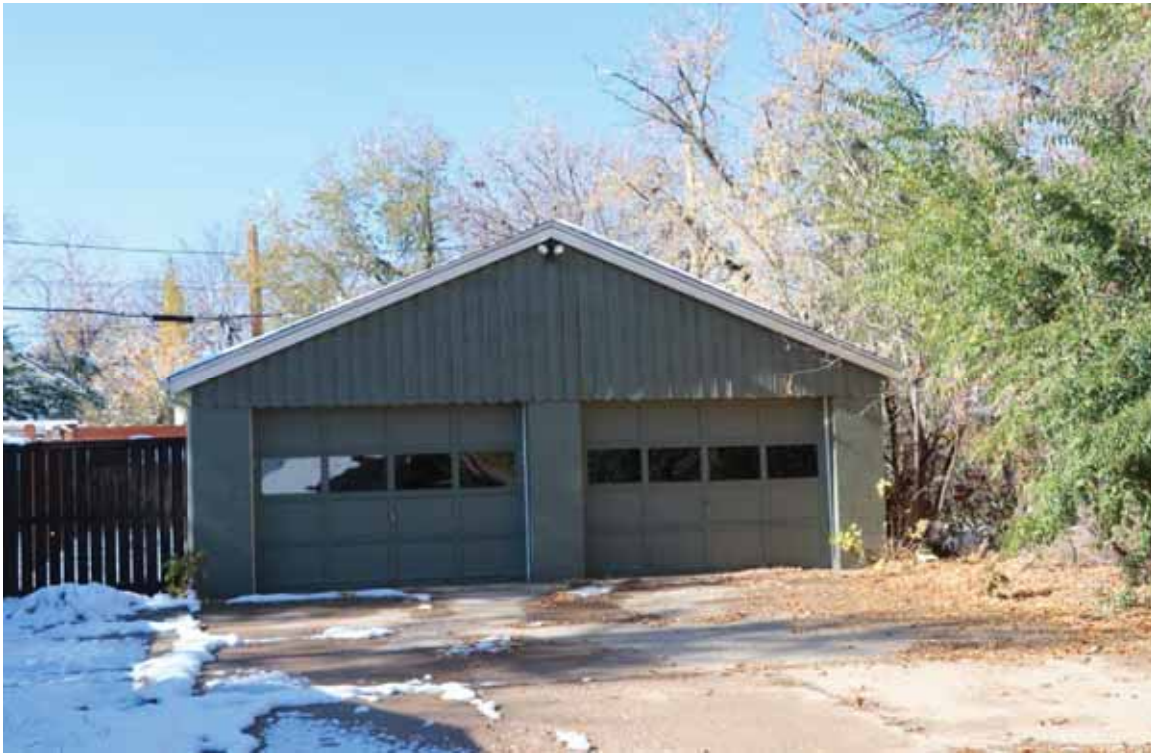
| <i>Element</i> | <i>Description &amp; Condition</i> | <i>Evaluation</i> | <i>Recommendation</i> |
|---|---|---|---|
| Associated Landscape Features | Detached two car garage located in the northwest portion of the property. Some cracks around openings. Built prior to 1962. | Fair | Determine if movement has stopped. Patch cracks |

Image 5: Associated Landscape Feature\_Detached Garage

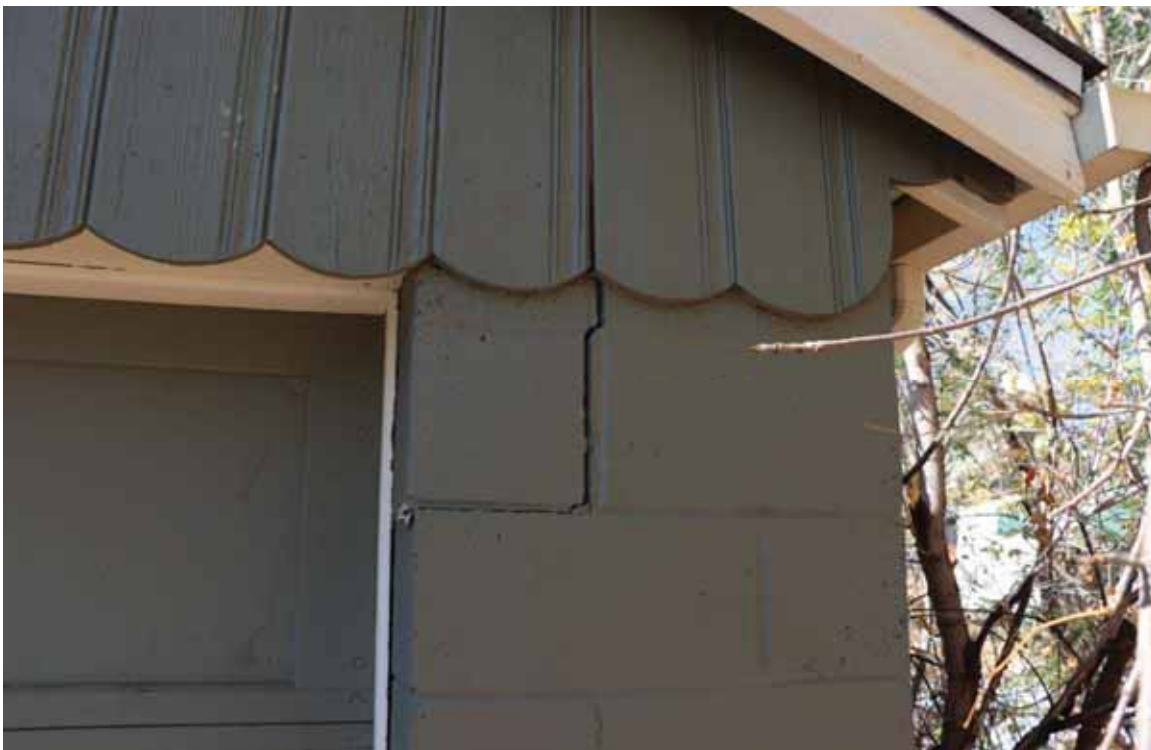
Image 6: Associated Landscape Feature Detached Garage Crack by door

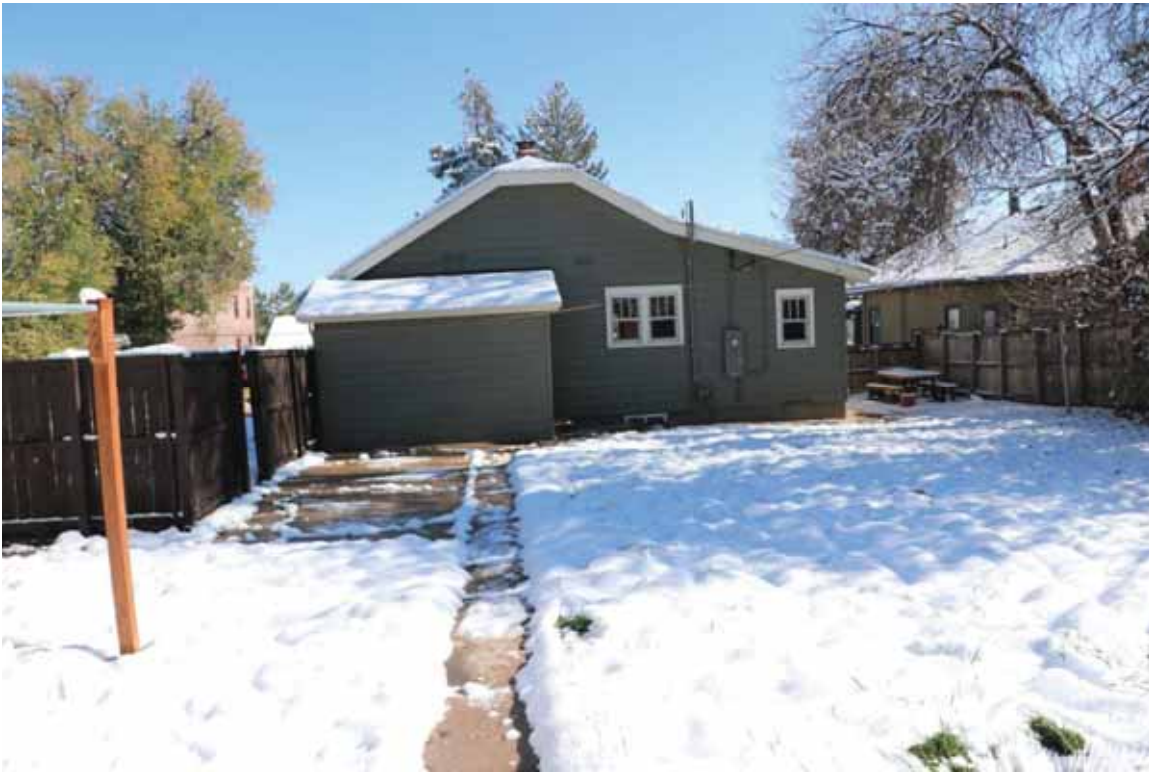
| <i>Element</i> | <i>Description &amp; Condition</i> | <i>Evaluation</i> | <i>Recommendation</i> |
|---|---|---|---|
| Grading | The lot slopes from the rear of the property to the street. Concrete curbs have been built along the rear to prevent water infiltration. Multiple cracks in the concrete. Some minor efflorescence was noted on the rear basement wall. | Fair | Recommend installation of a French drain along the rear of the home to guide drainage along the sides to the street. Repair cracked concrete and curbs |

Image 7: Grading\_ Lot slopes from rear of the home to the street. View facing towards Main Street

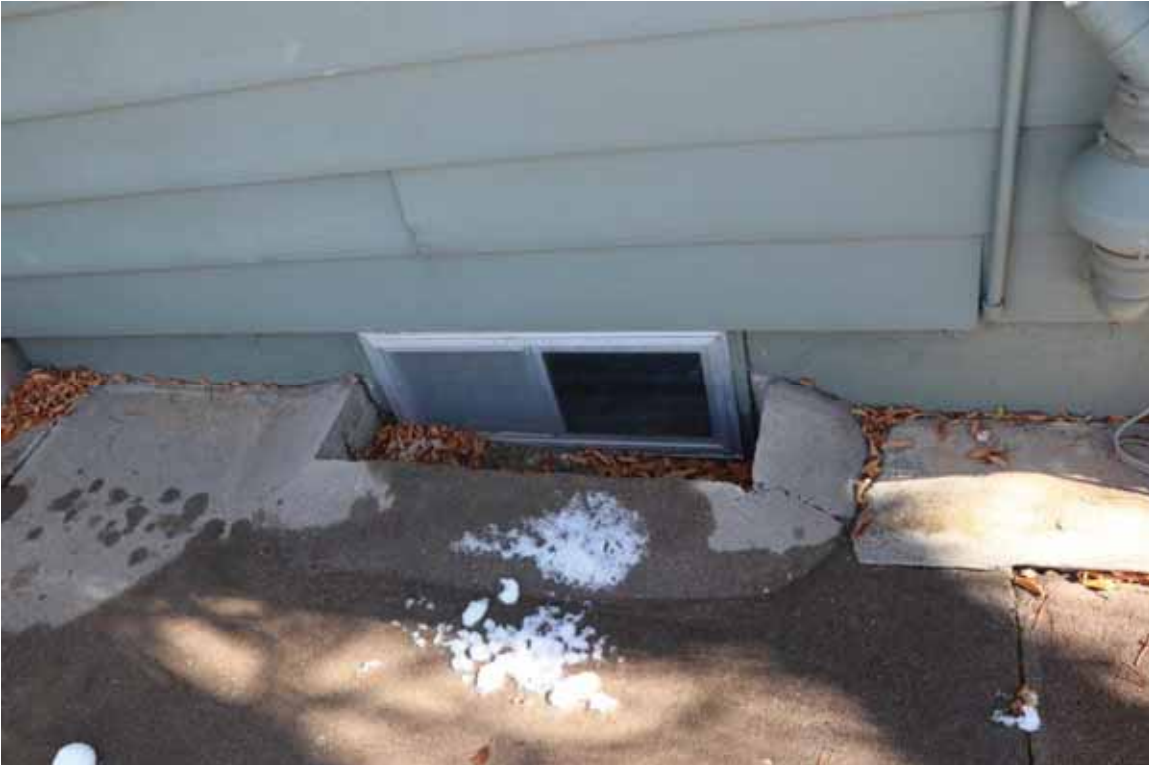
Image 8: Grading\_ Lot slopes from rear of the home to the street. Curb around basement window

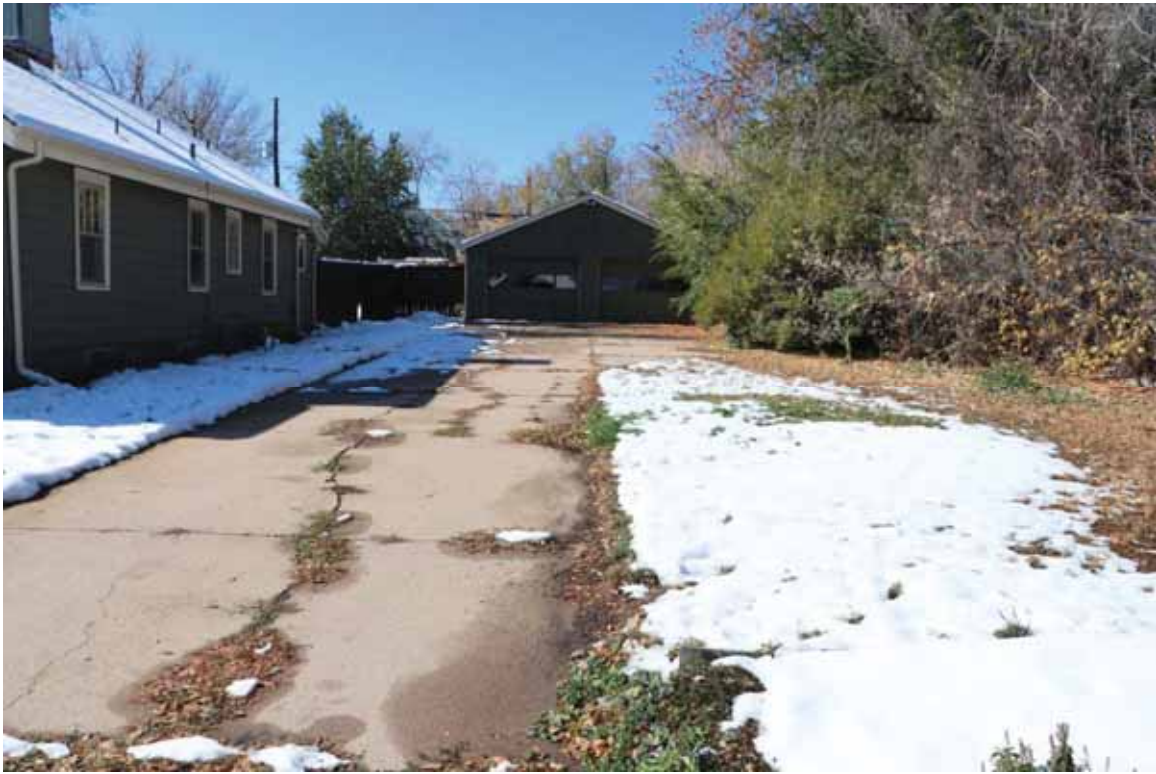
| <i>Element</i> | <i>Description &amp; Condition</i> | <i>Evaluation</i> | <i>Recommendation</i> |
|---|---|---|---|
| Parking | There is a wide concrete driveway on the north side of the home leading to the detached garage. Driveway is heavily cracked. An animal has made a home underneath the western portion | Poor | Replace driveway, ensuring that the drainage slope is away from the home |

Image 9: Parking Concrete driveway

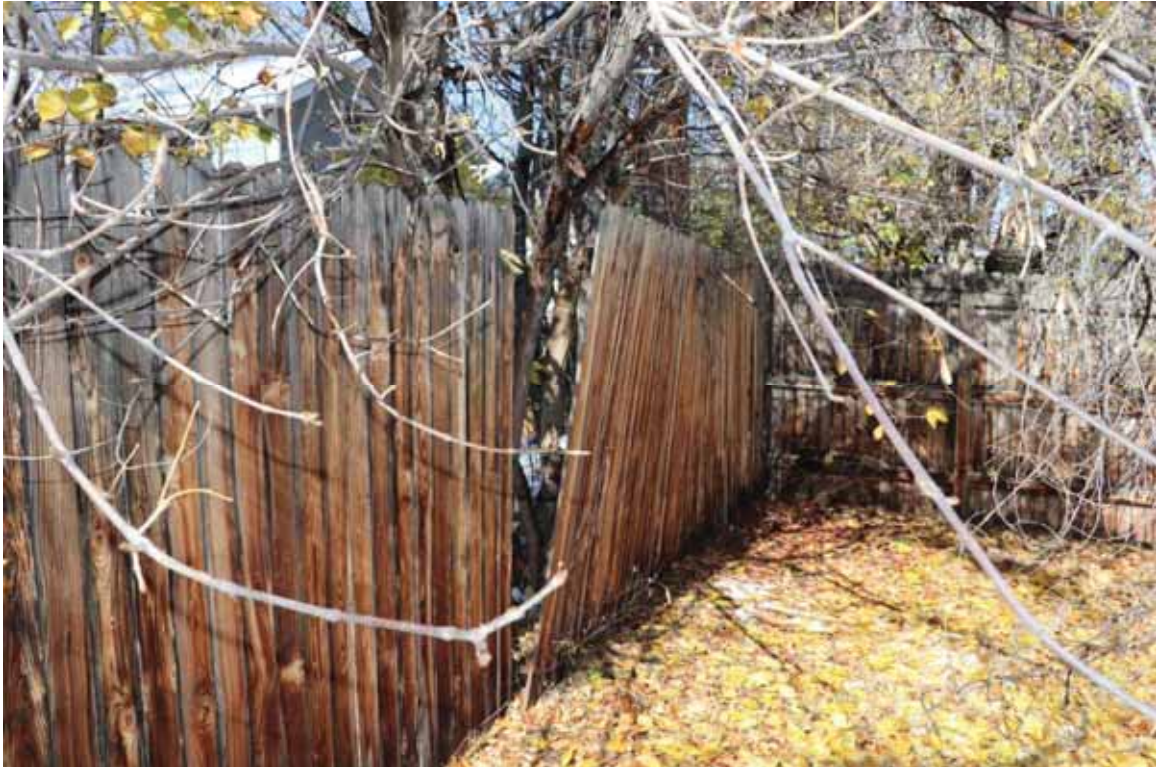
| <i>Element</i> | <i>Description &amp; Condition</i> | <i>Evaluation</i> | <i>Recommendation</i> |
|---|---|---|---|
| Fencing | The rear yard of the home is fenced with 6' cedar. There is one panel that has been dislodged by a neighbors tree | Fair | Gain permission to trim back adjacent tree. Reattached dislodged panel |

Image 10: Fencing Panel dislodged at west end

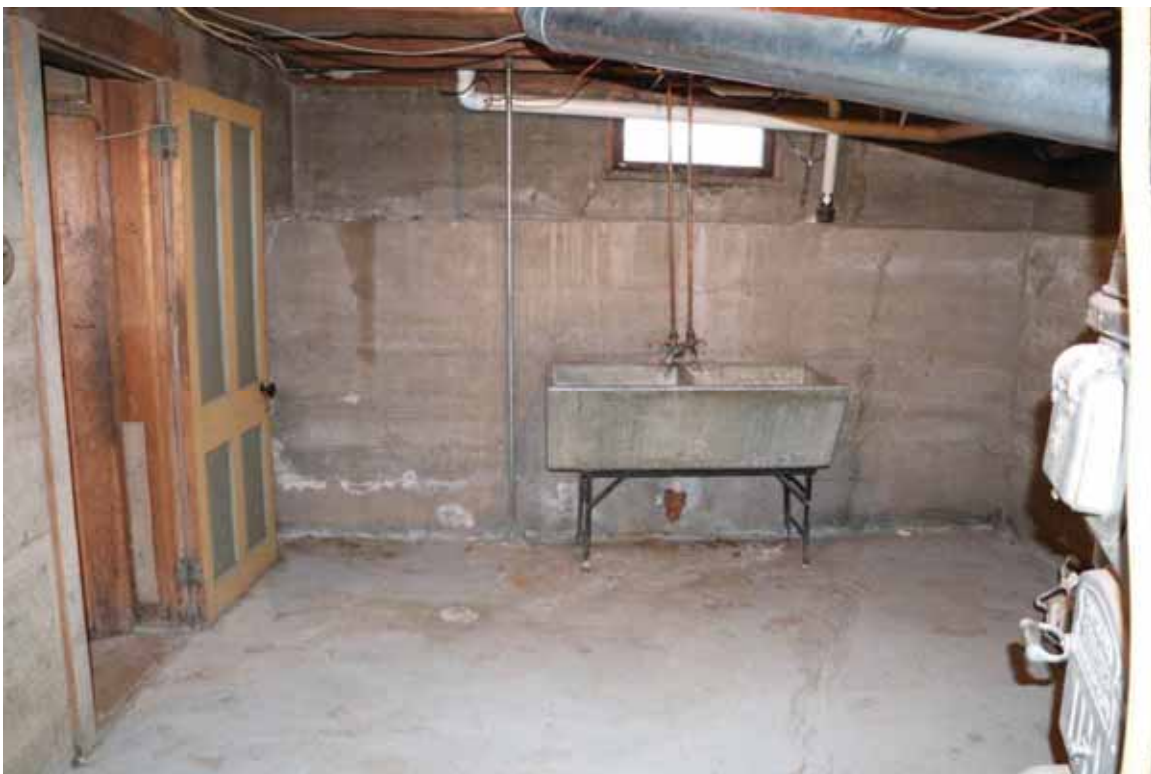
Image 11: Foundation Systems\_ Poured concrete on grade with concrete walls. Stepped poured concrete foundation walls common throughout the basement

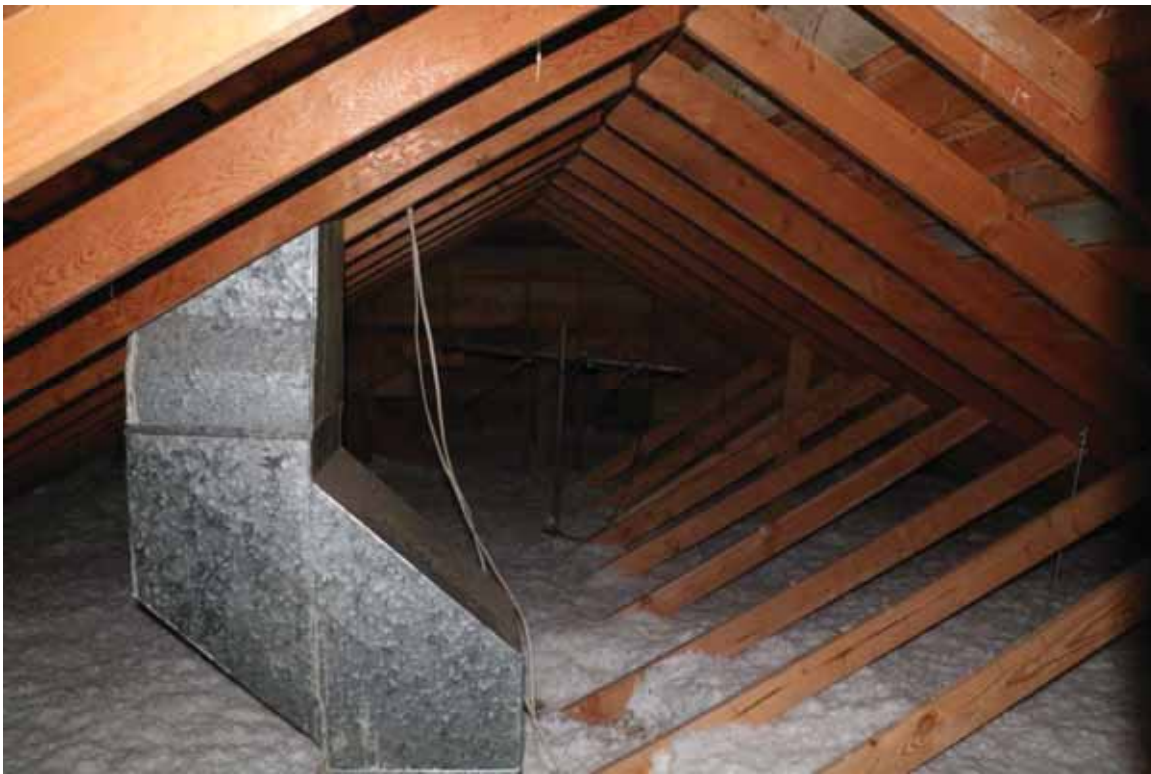
| <i>Element</i> | <i>Description &amp; Condition</i> | <i>Evaluation</i> | <i>Recommendation</i> |
|---|---|---|---|
| Roof Framing System | The roof framing system consists of 2"x6" wood rafters butt jointed to a ridge beam. There are no collar ties. Purlins have been added to the structure at some point throughout the roof structure except in the northeast quarter of the roof. The reason for the lack of bracing in that area was not able to be determined. The added purlins are bolted to the existing rafters. In addition, metal tie rods were added at the purlin-rafter connection point vertically to the attic joists. The insulation prevented a clear view of how they were connected at the joists | Good | Reinforce framing system per engineers report |

Image 14: Roof Framing Systems\_ 2x6, 24"OC. View facing towards Main Street. Note the lack of purlins on the NE quarter

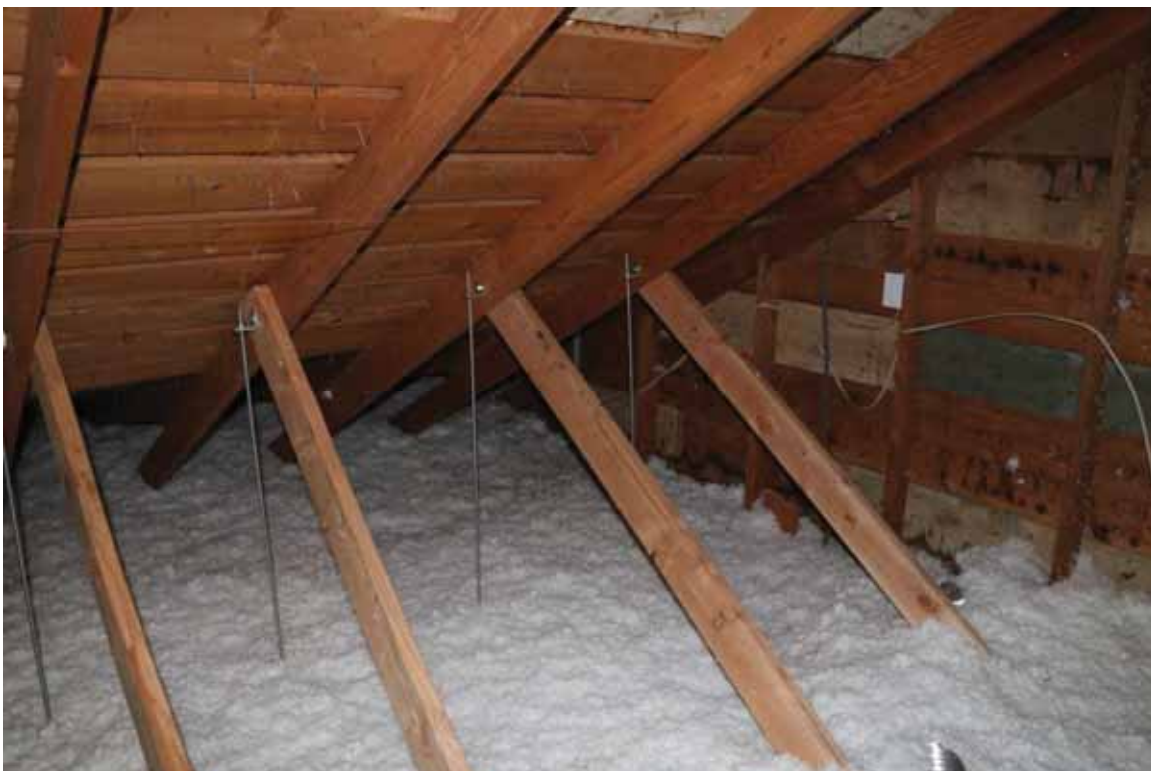
Image 15: Roof Framing Systems\_ Note the vertical metal tie rods. As they are attached with L-brackets, it is assumed that they are not designed to carry much weight

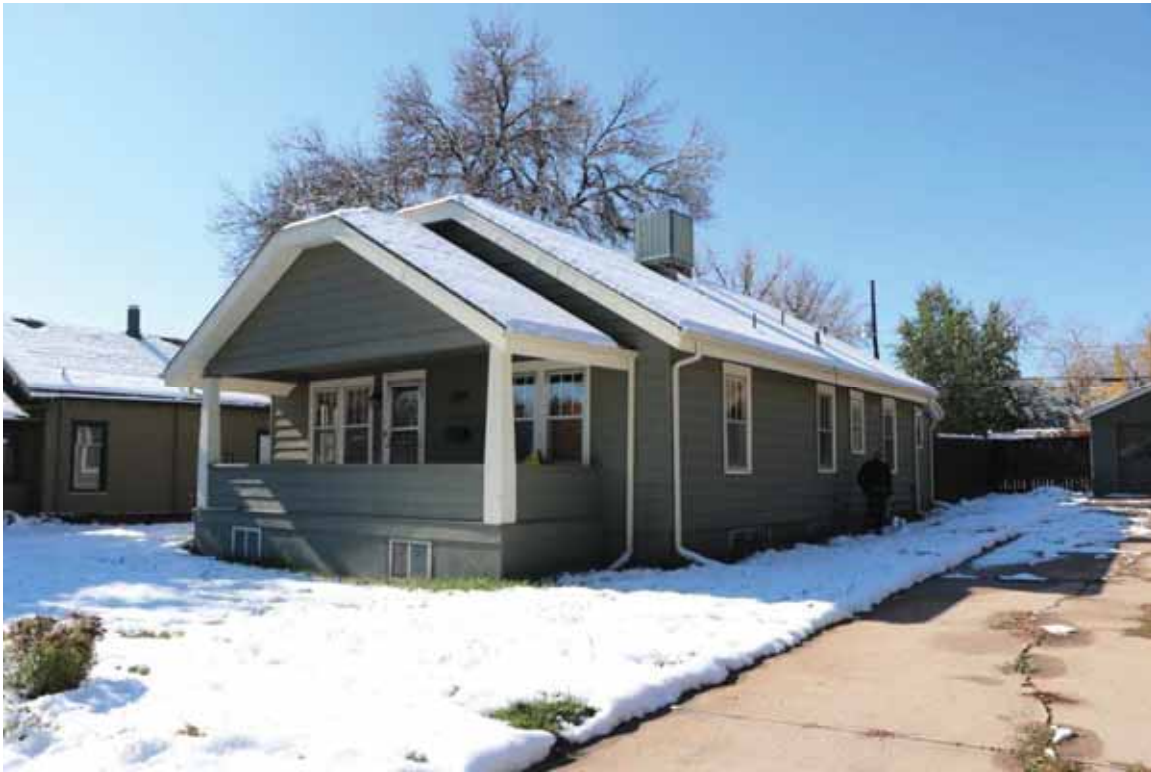
| Entry Porch | <p>The entry porch is wood framed with a wood floor. There are steps on the south side from a concrete sidewalk. The ceiling, solid wall railing, and tapered columns are all coated in stucco. This stucco appears to be a more recent skim coat, and a pale yellow stucco can be seen underneath where the top coat has been damaged. The basement extends to underneath the porch, and there is a concrete wall supporting the outer edge of the porch and another wall at the house wall, creating a vault underneath. The floor of the porch creates the roof of the basement vault, and water infiltration and mold are evident.</p> | Good | <p>The porch floor needs to be sealed with managed drainage to prevent water infiltration into the basement.</p> |

Image 16: Entry Porch

| Low to medium Priority | | | | | |
|---|---|---|---|---|---|
| Redesign front porch floor to prevent water infiltration into the basement | 1 | EA | \$ 8,500.00 | \$ | 8,500 |

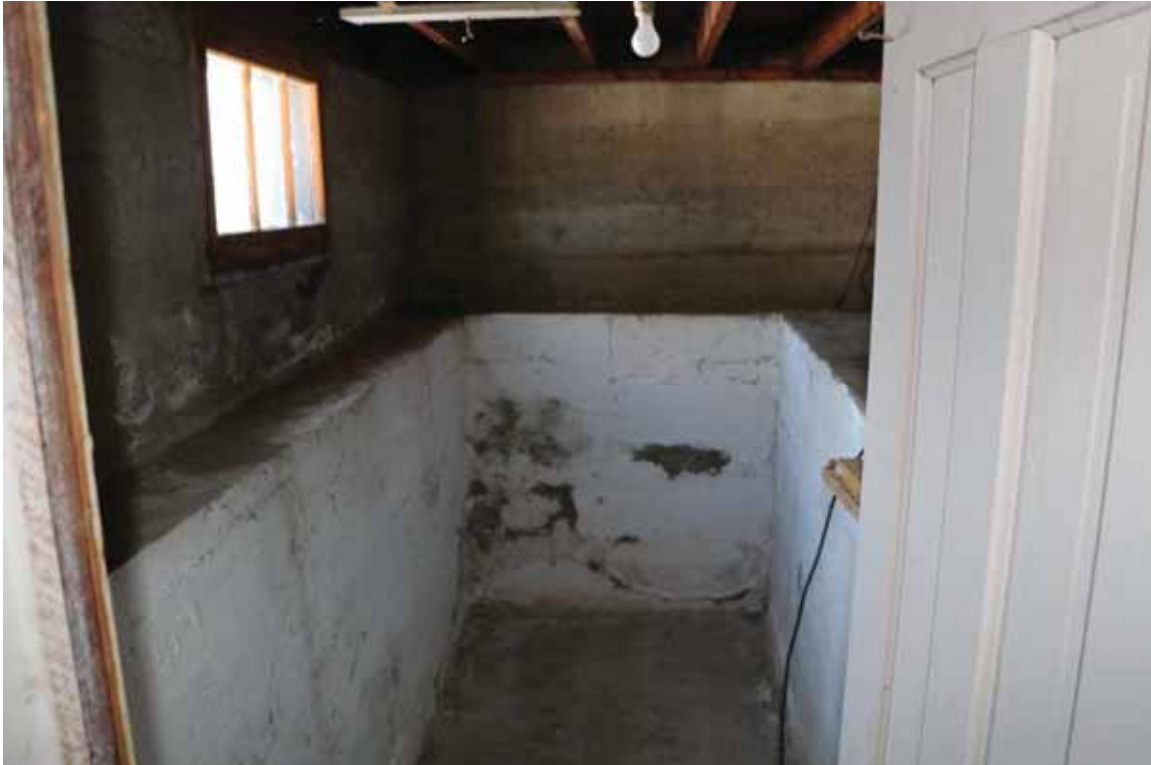
Image 17: Entry Porch\_ Basement room directly under porch

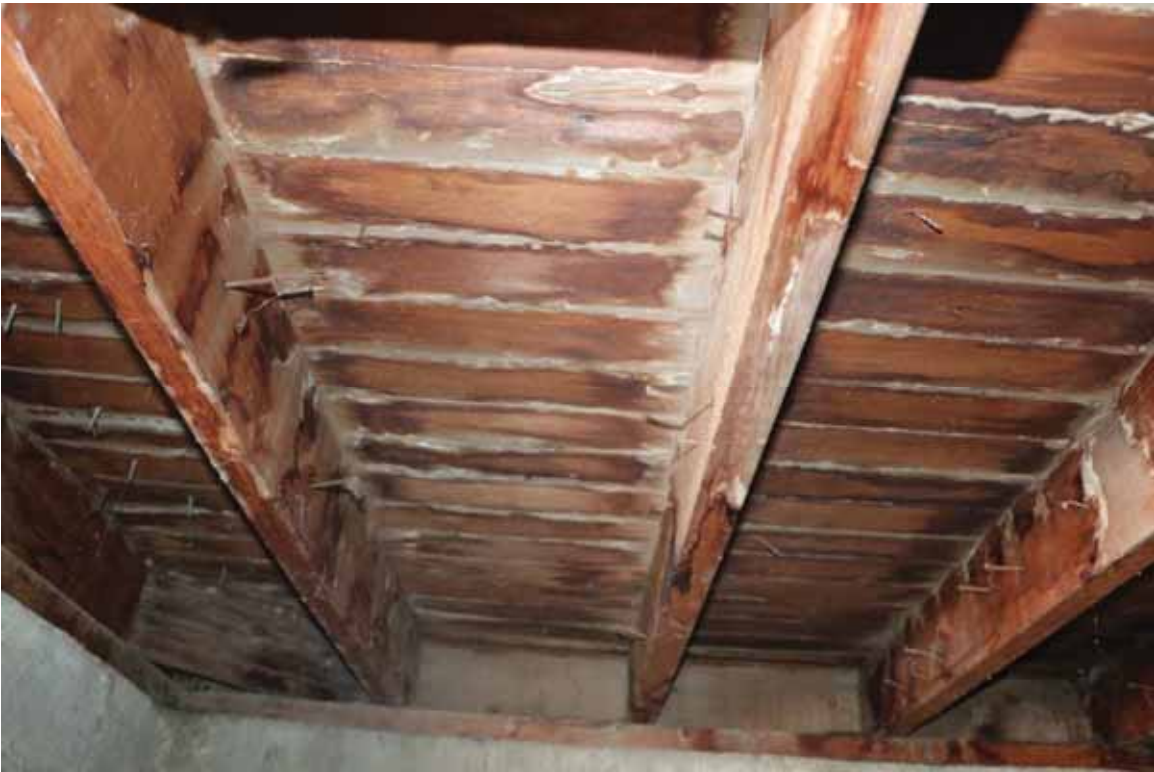
Image 18: Entry Porch\_ Underside of porch floor

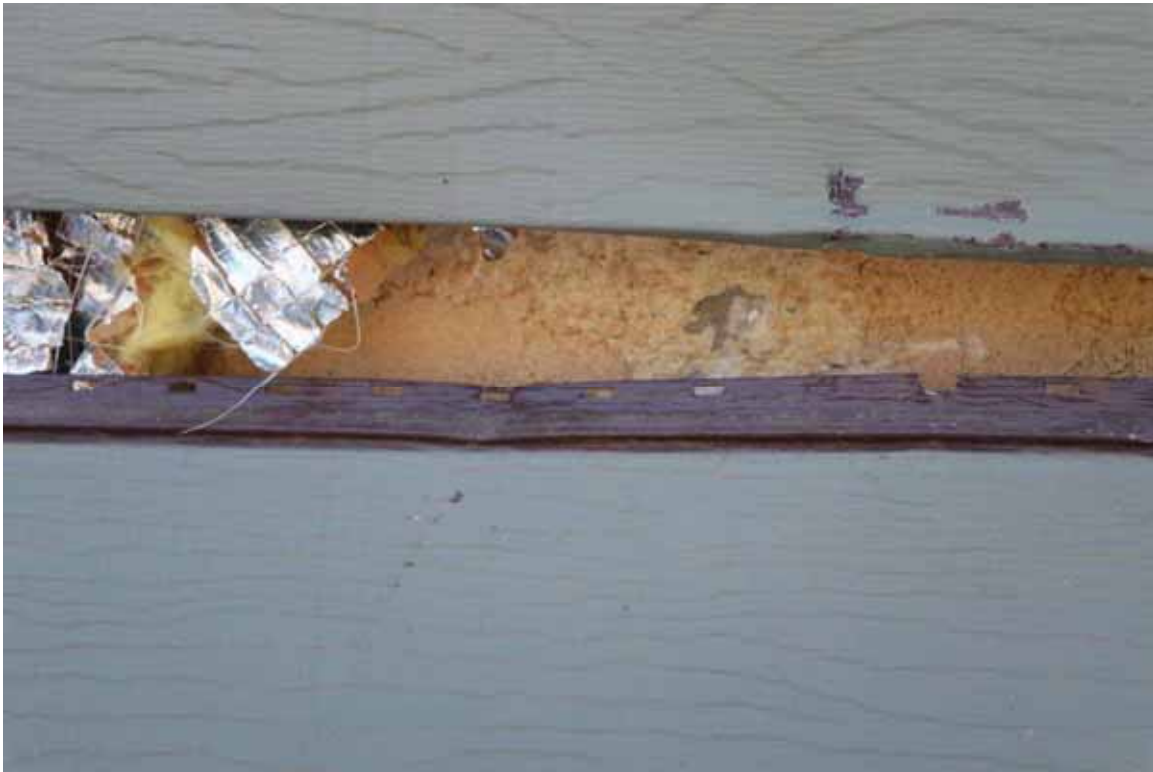
Non-structural changes to the property include the addition of siding over the older stucco siding, which likely occurred in 1975 per the Building Permit files. Windows appear to be original.

Image 19: Exterior Finishes\_ A section where the siding has slipped shows the stucco underneath

| Remove alumn siding and repair historic stucco siding on walls, repair soffits, and fascia | 2500 | SF | \$ | 12.50 | \$ | 31,250 |

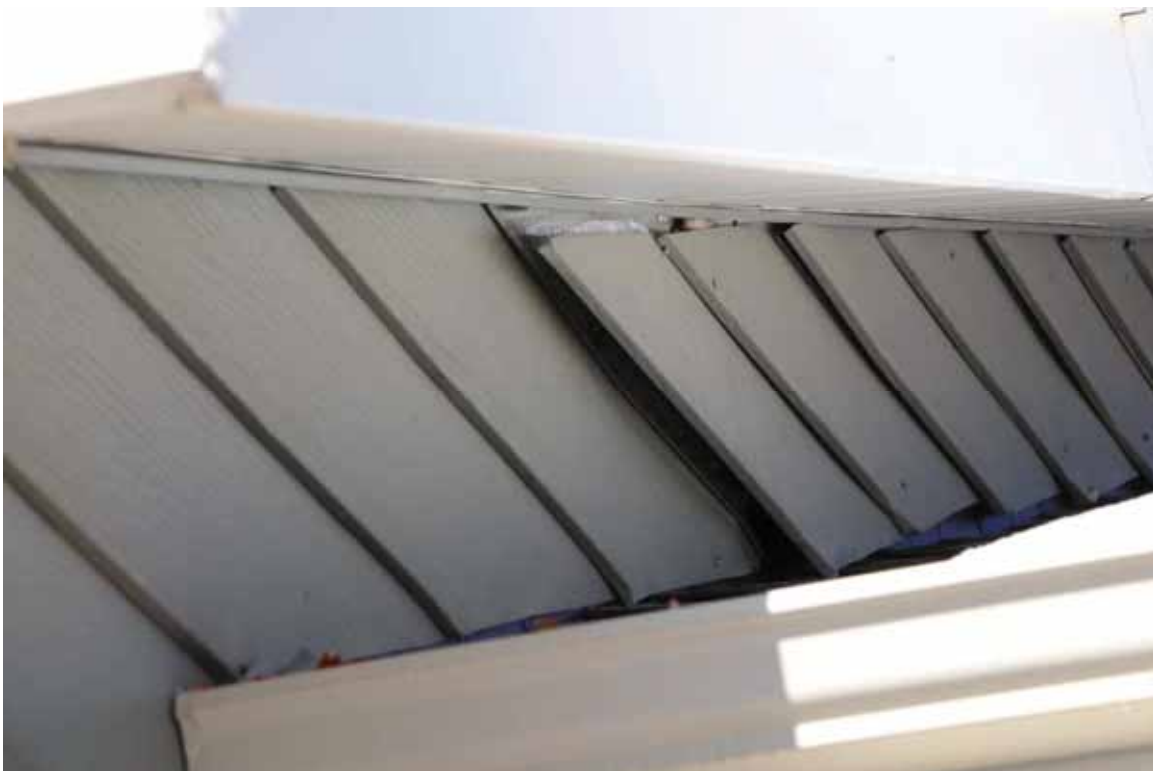
Image 20: Exterior Finishes\_ Loose siding

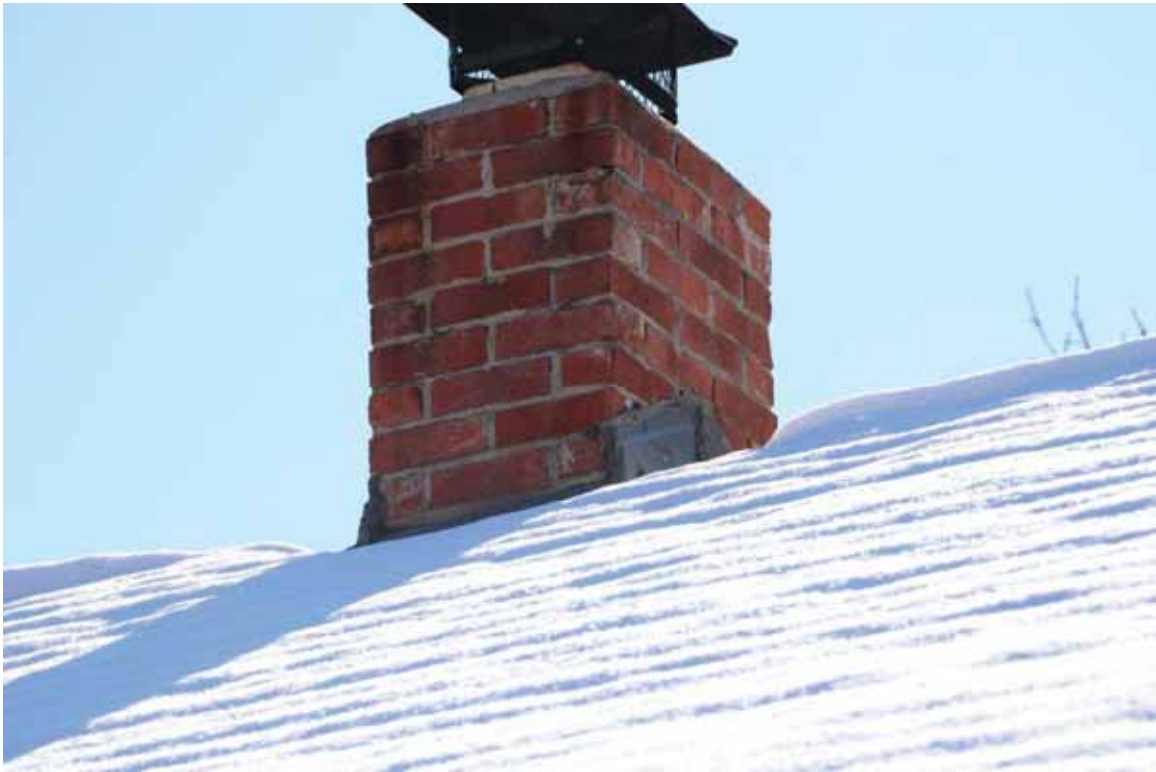
| Element | Description & Condition | Evaluation | Recommendation |
|---|---|---|---|
| Exterior Masonry | The above grade portion of the poured foundation is in good condition. The brick chimney is in good condition. | Good | Inspect the chimney annually for mortar and flashing deterioration |

Image 21: Exterior Masonry\_ Brick Chimney

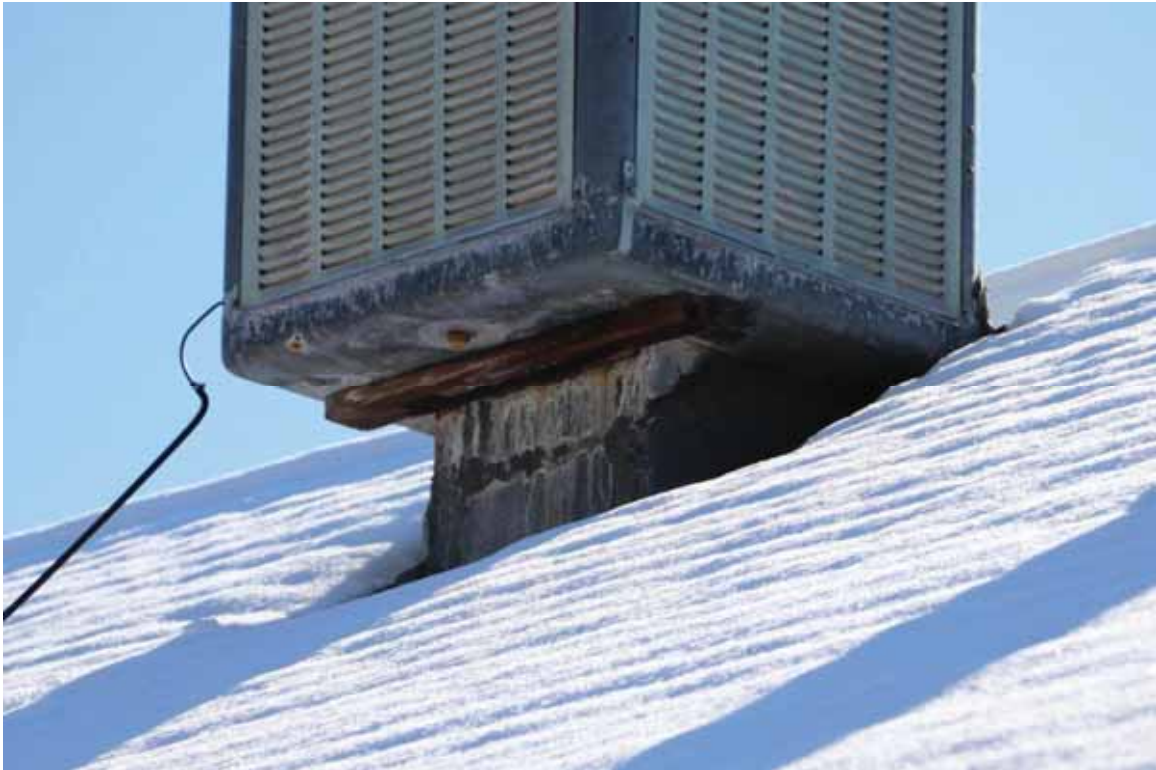
Image 22: Sheet Metal Flashing\_ Swamp cooler flashing

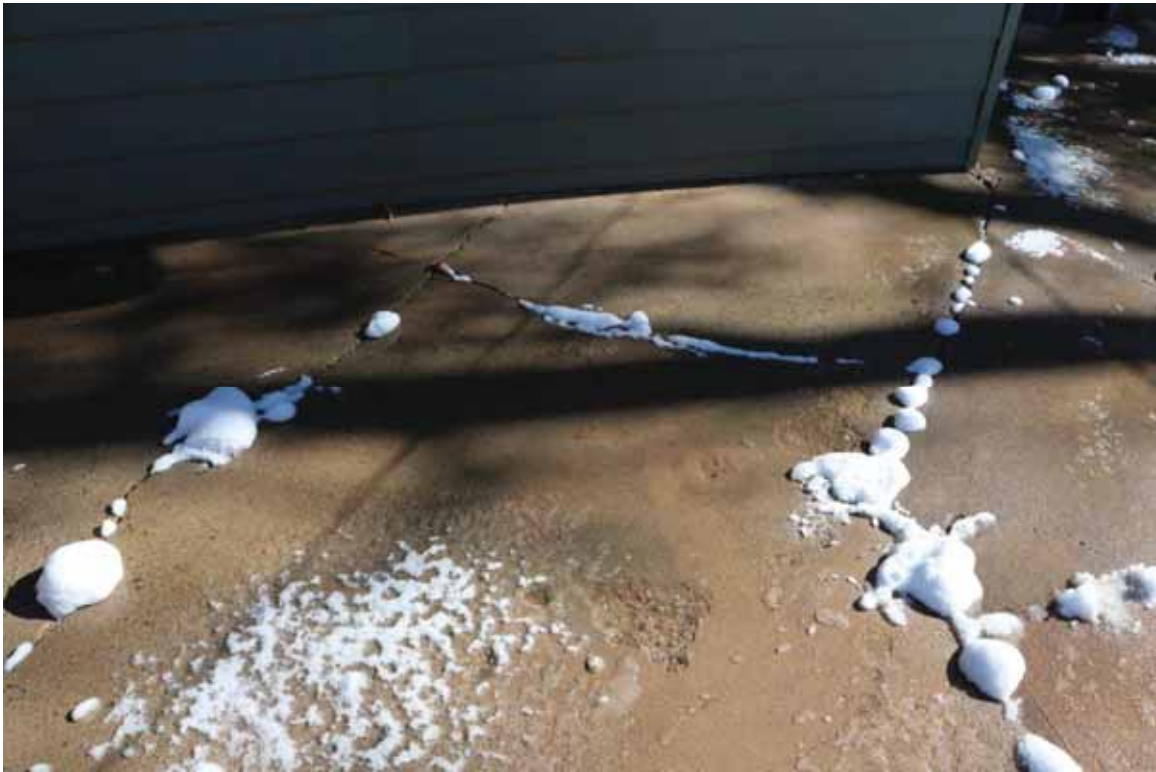
Image 23: Perimeter Foundation Drainage\_ Concrete poured up against the rear of the home is cracked and allowing surface water in penetrate

| High Priority | | | | | |
|---|---|---|---|---|---|
| Foundation waterproofing | 1 | EA | \$ 10,500.00 | \$ | 10,500 |

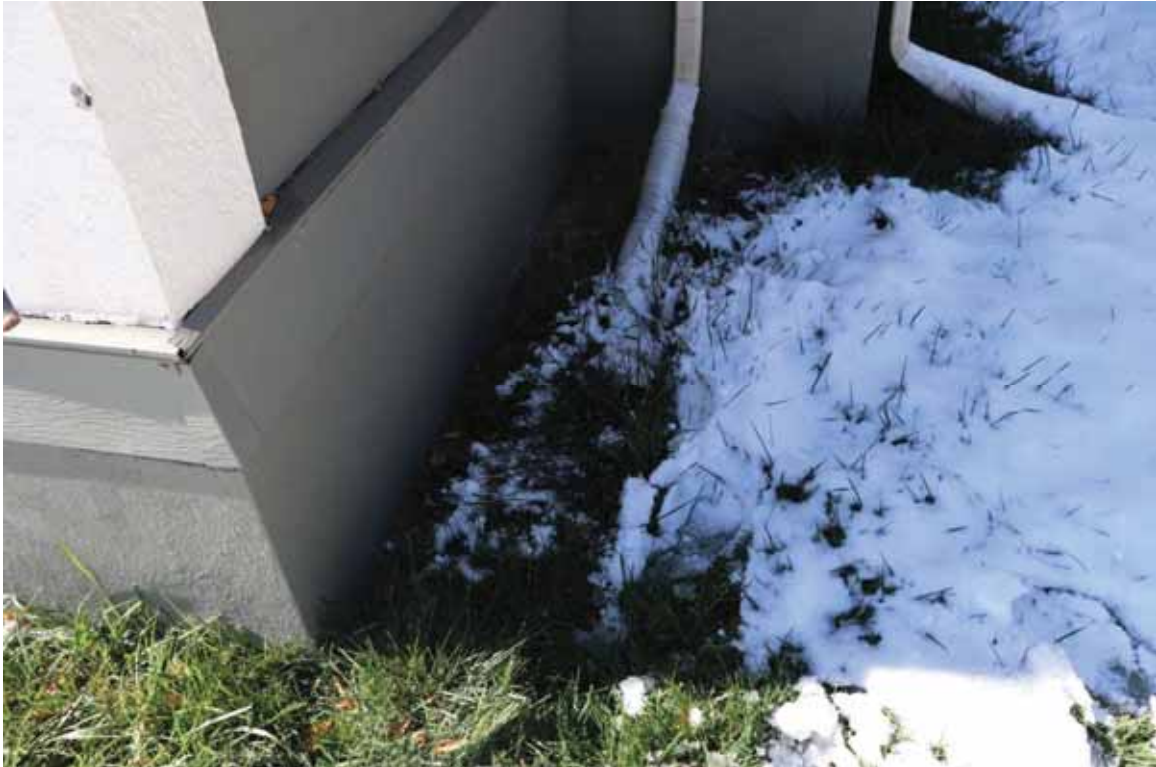
| Element | Description & Condition | Evaluation | Recommendation |
|---|---|---|---|
| Drainage System, Gutters & Downspouts | Gutters are in good condition. Downspouts discharge water too close to the foundation of the building, causing water to infiltrate the basement. | Fair | Extend the downspouts so that water is discharged at least six feet from the foundation and on a grade flowing away from the home. |

Image 24: Drainage System, Gutters & Downspouts\_ Discharge is too close to the foundation

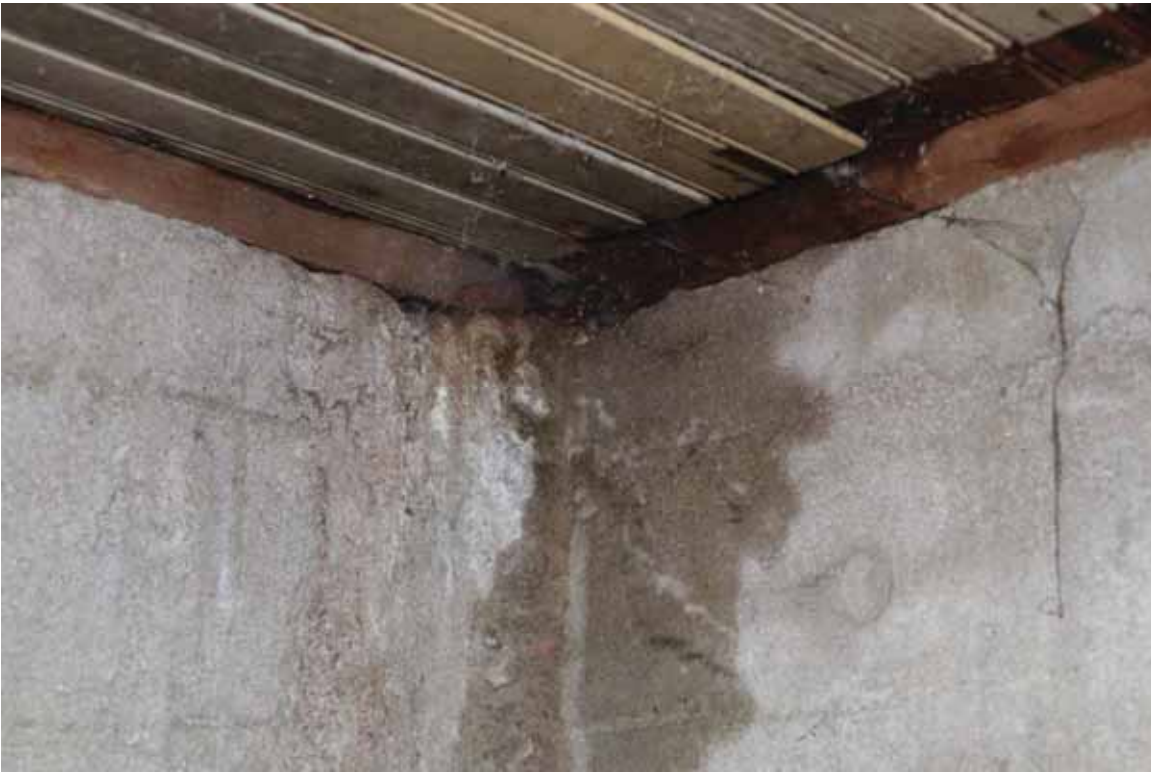
Image 25: Drainage System, Gutters & Downspouts\_ Active water infiltration in basement directly adjacent to previous photo of downspout

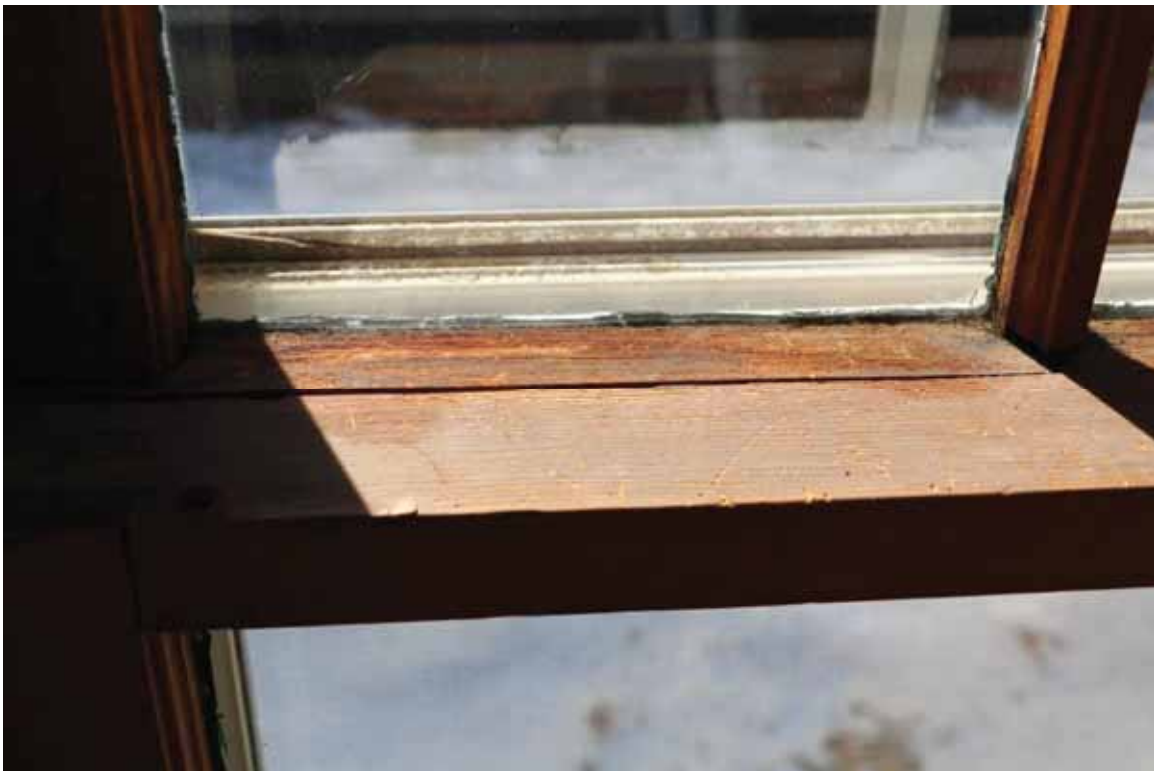
| Element | Description & Condition | Evaluation | Recommendation |
|---|---|---|---|
| Windows (including Hardware, Casing/Trim, and Finishes) | <p>Window casing matches the doors.</p> <p>Windows on the main level are three-over-one, wood, double-hung windows with spring-pin stays. The windows are stained and varnished except for the kitchen and dinette windows, which are painted. The kitchen windows have been modified with tape balances.</p> <p>The windows are all in good condition, with no repairs needed that would be outside of a general maintenance scope.</p> <p>There are storm windows on the exterior</p> <p>Basement windows are a variety of types, including replacement windows. The oldest surviving style is the three-lite wood awning-style windows in fair condition</p> | <p>Good-<br/>Main level</p> <p>Fair-<br/>Basement</p> | <p>Main level: Perform general maintenance. Paint and glazing putty touchups. Lubricate spring pins.</p> <p>Basement: Clear debris from exterior. Ensure positive drainage away from building. Windows would require a level 2 restoration per the National Park Service Preservation Brief 9.</p> |

Image 29: Windows\_ Typical level of deterioration

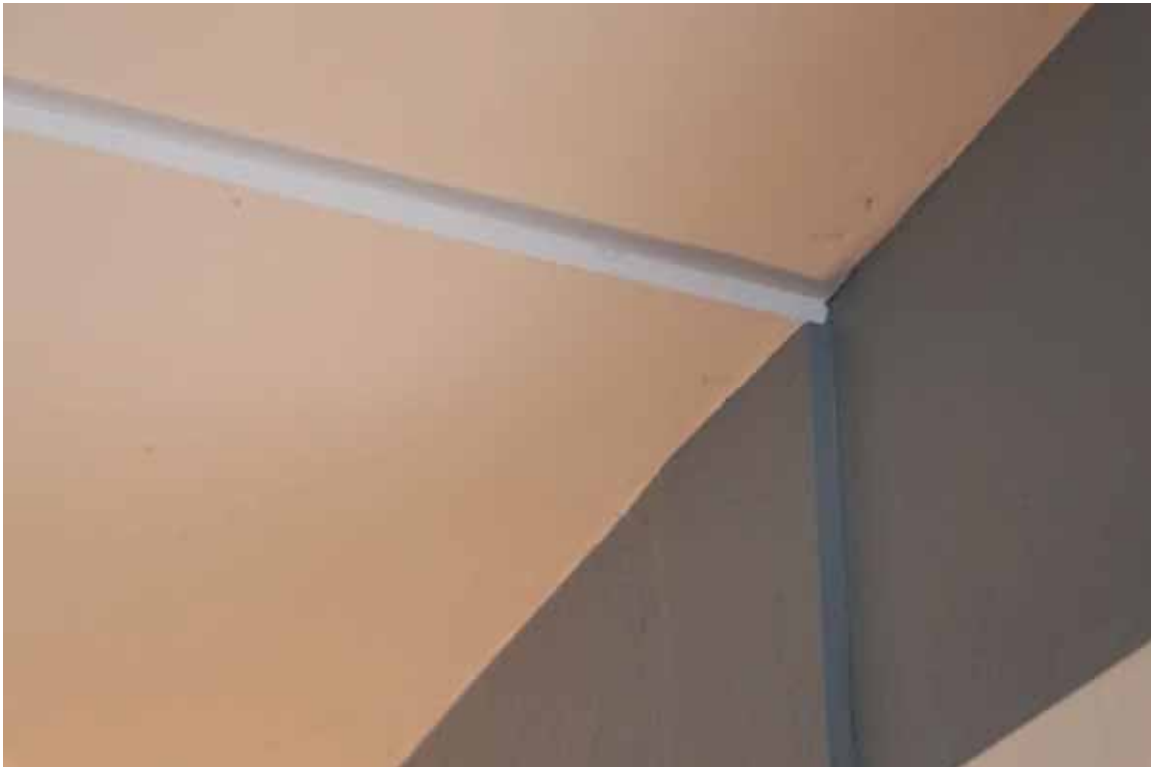
Image 31: Wall Finish Materials\_ Drywall/plaster seam at the kitchen

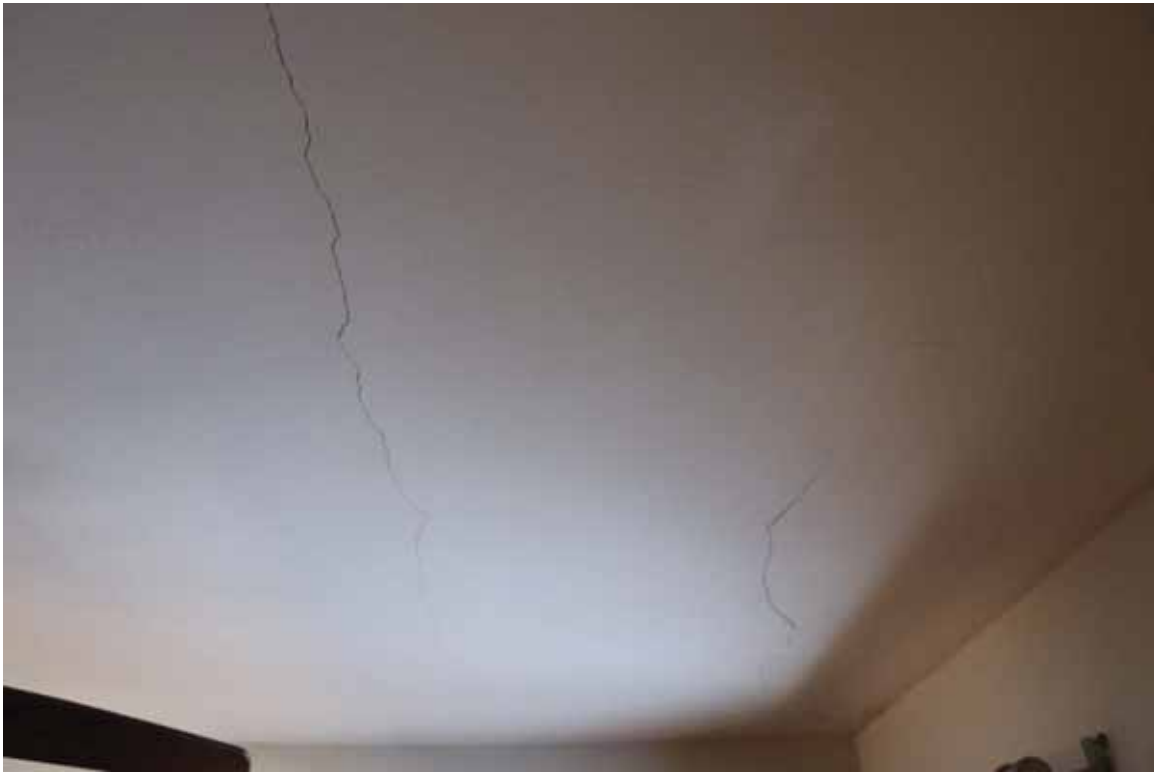
Image 32: Ceiling Finish Materials\_ Ceiling cracks in bedroom

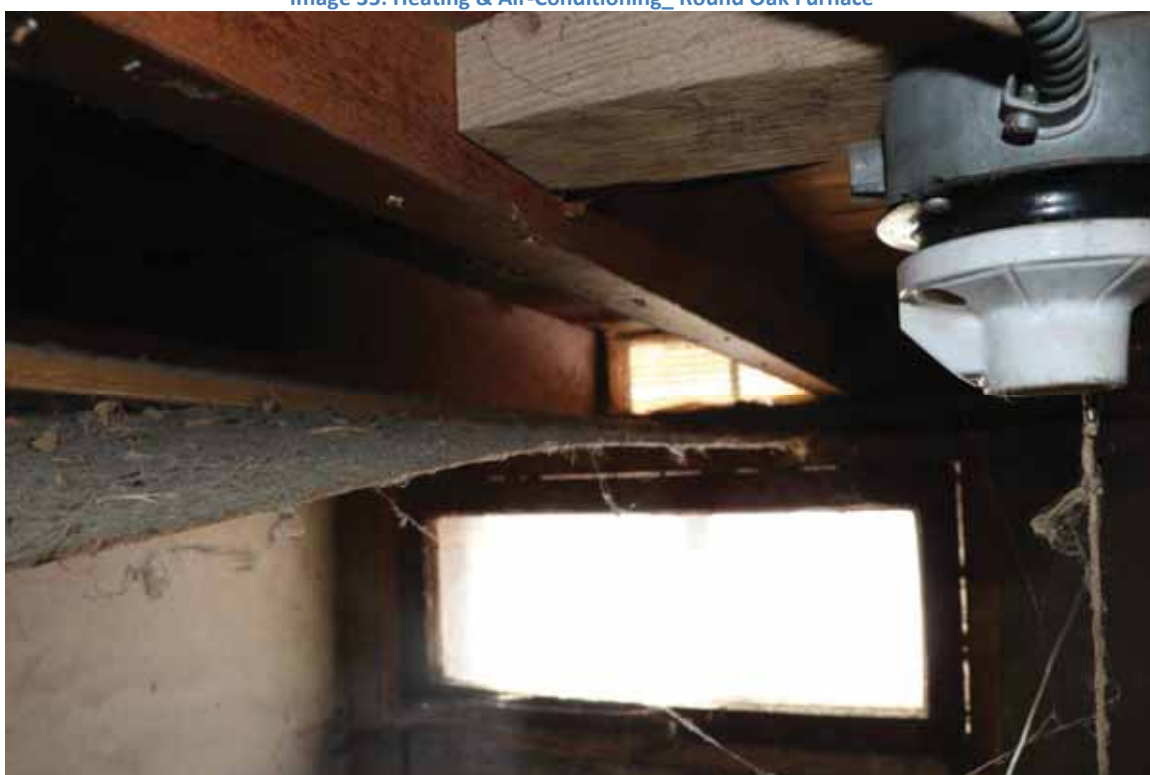
Image 36: Heating & Air-Conditioning\_ Supply air duct for furnace has failed
