**SUBJECT:** RESOLUTION NO. 30, SERIES 2023 – A RESOLUTION APPROVING A PRESERVATION AND RESTORATION GRANT FOR THE COLACCI HOUSE AT 1209 MAIN STREET

# 1209 Main Street

## Historic Structure Assessment

#### 3.0 Condition Assessment

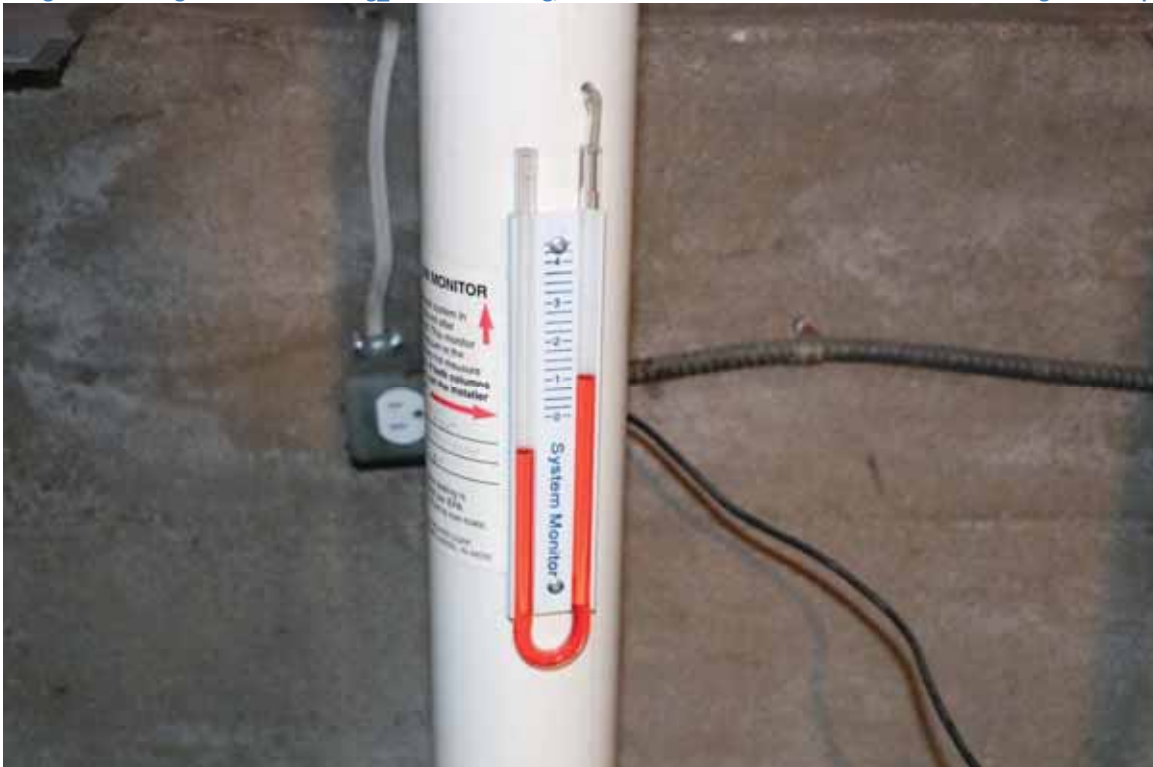
Image 38: Ventilation\_ Radon system is functional

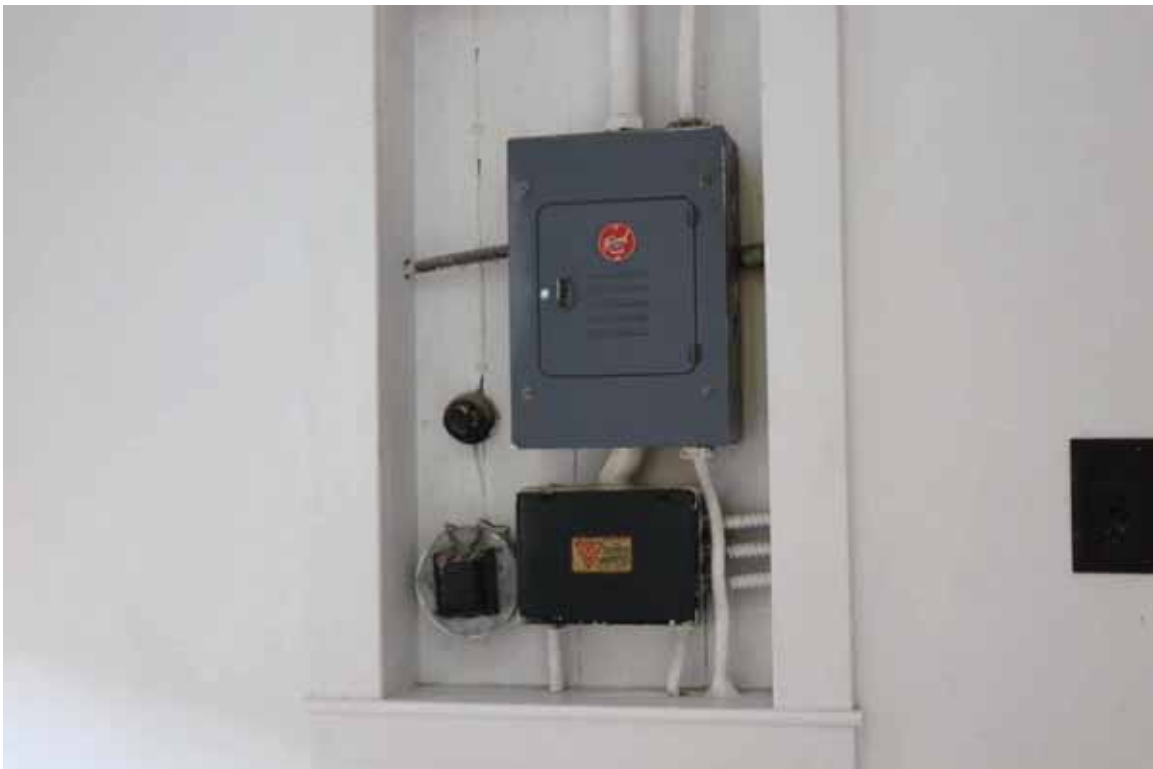
Image 40: Electrical Service & Panels\_ Federal "NoArk" panel and unknown associated electrical devices

| High Priority | | | | | |
|---|---|---|---|---|---|
| Electrical system repairs | 1 | EA | \$ 10,000.00 | \$ | 10,000 |

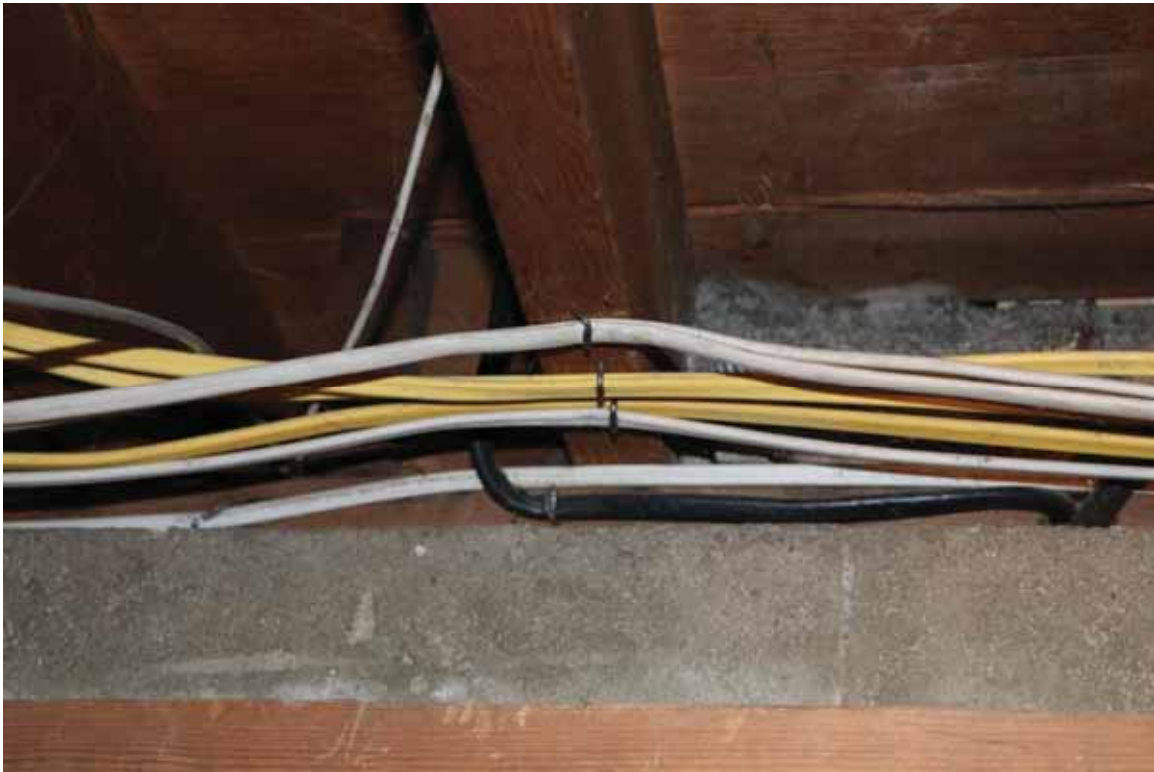
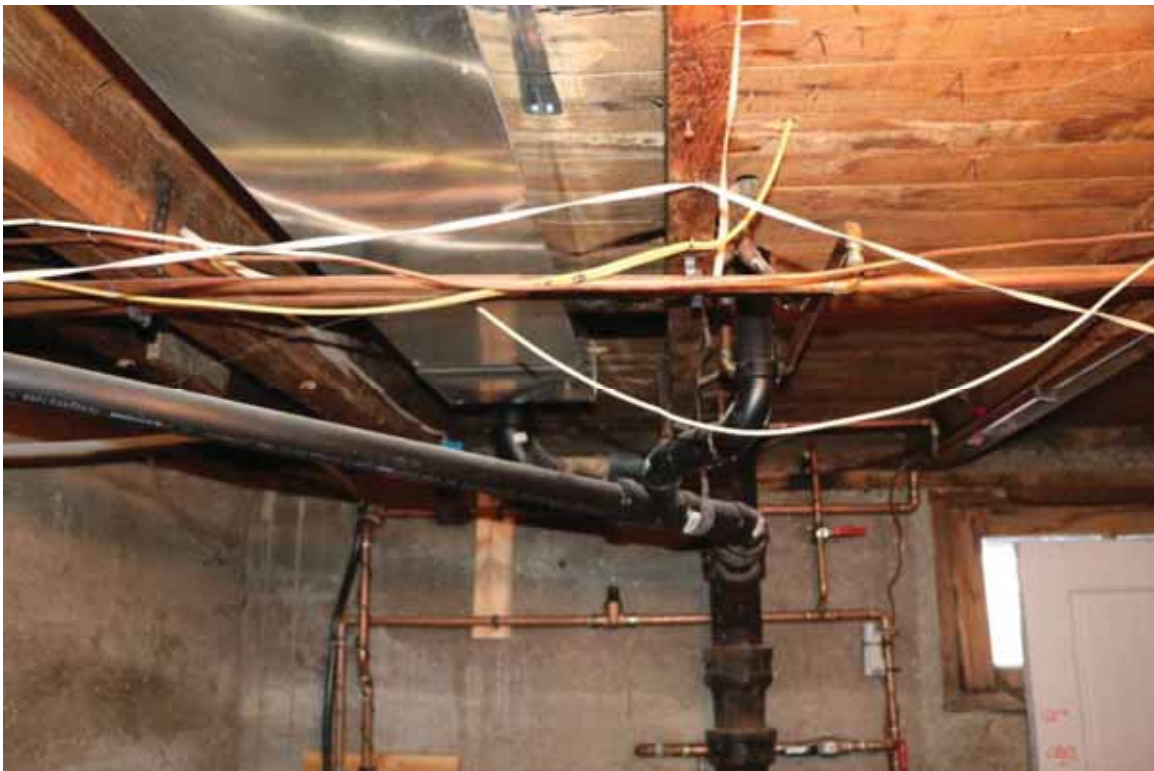
Image 41: Electrical Distribution System\_ Wiring improperly attached to exposed edge of joists

Image 42: Electrical Distribution System\_ Wiring improperly attached to exposed edge of joists

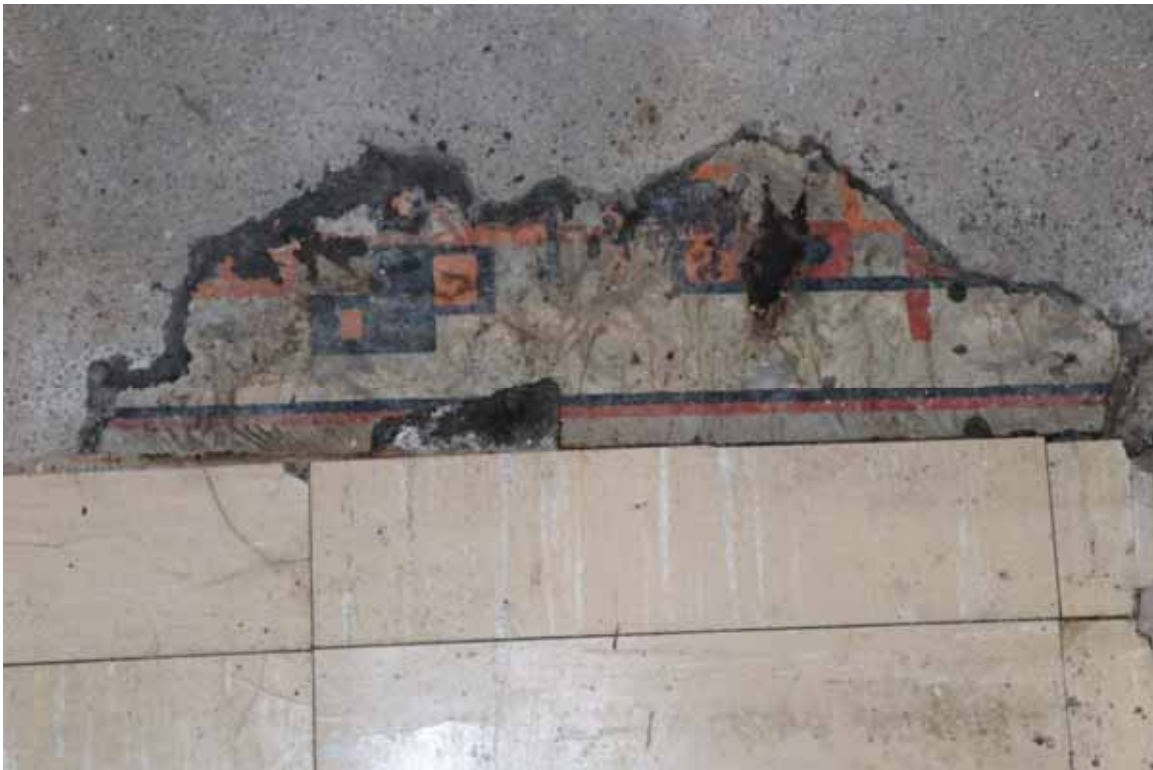
There are floor tiles in the basement that may contain asbestos, or their mastic may contain asbestos. These materials should be tested before they are disturbed.

Image 43: Basement floor tiles

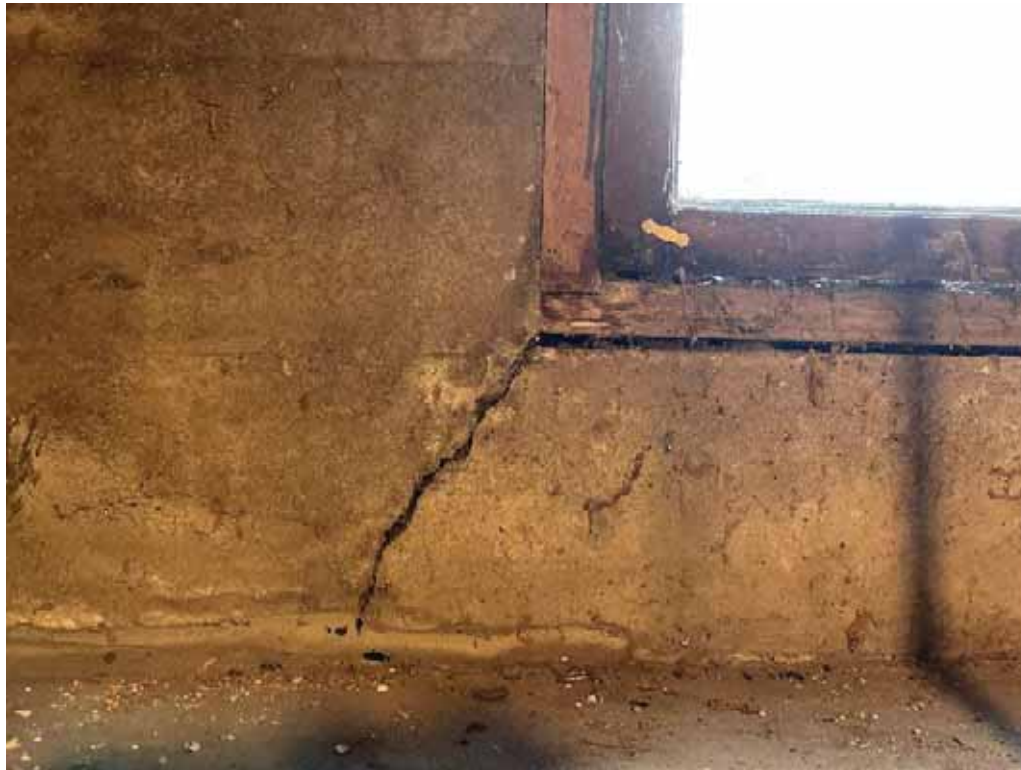
Figure 5: Settlement (or shrinkage) crack under window in west basement wall

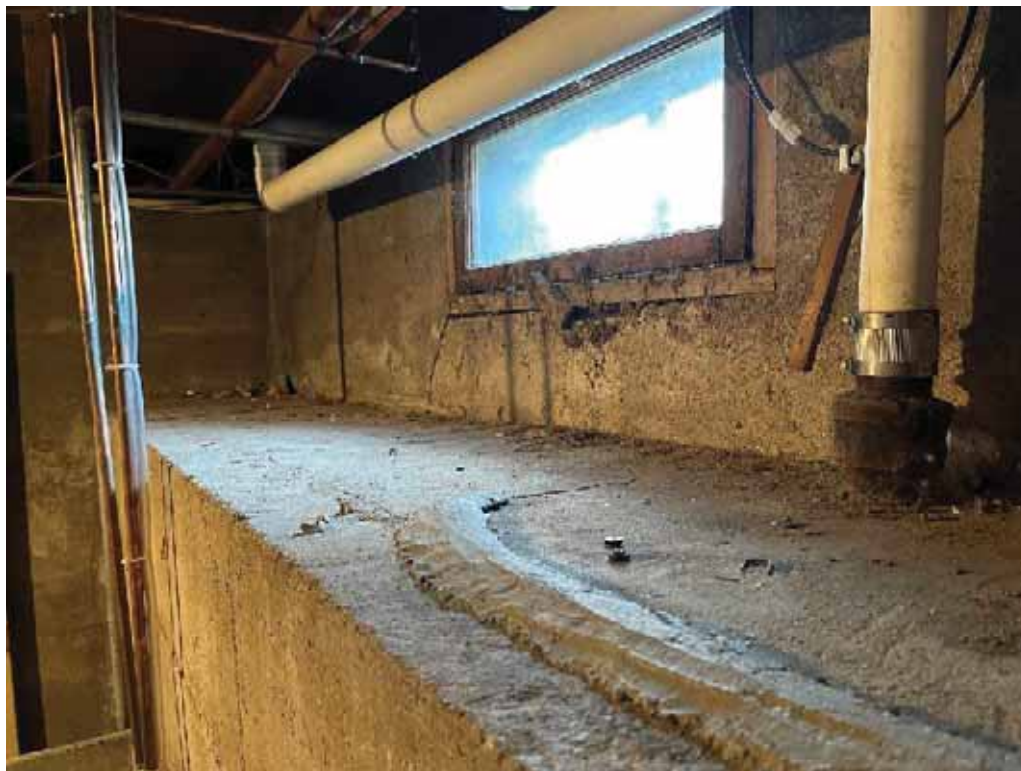
Figure 6: Repaired separation crack between top of retaining wall and concrete cap at west basement wall

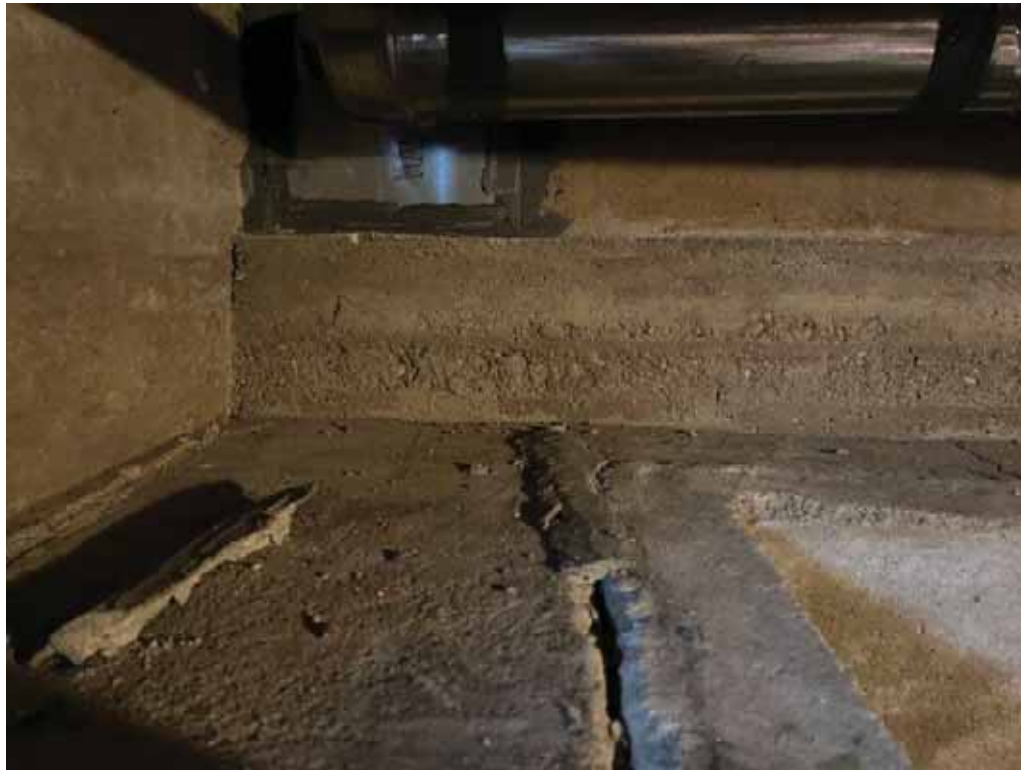
Figure 7: Repaired separation crack between top of retaining wall and concrete cap at west basement wall

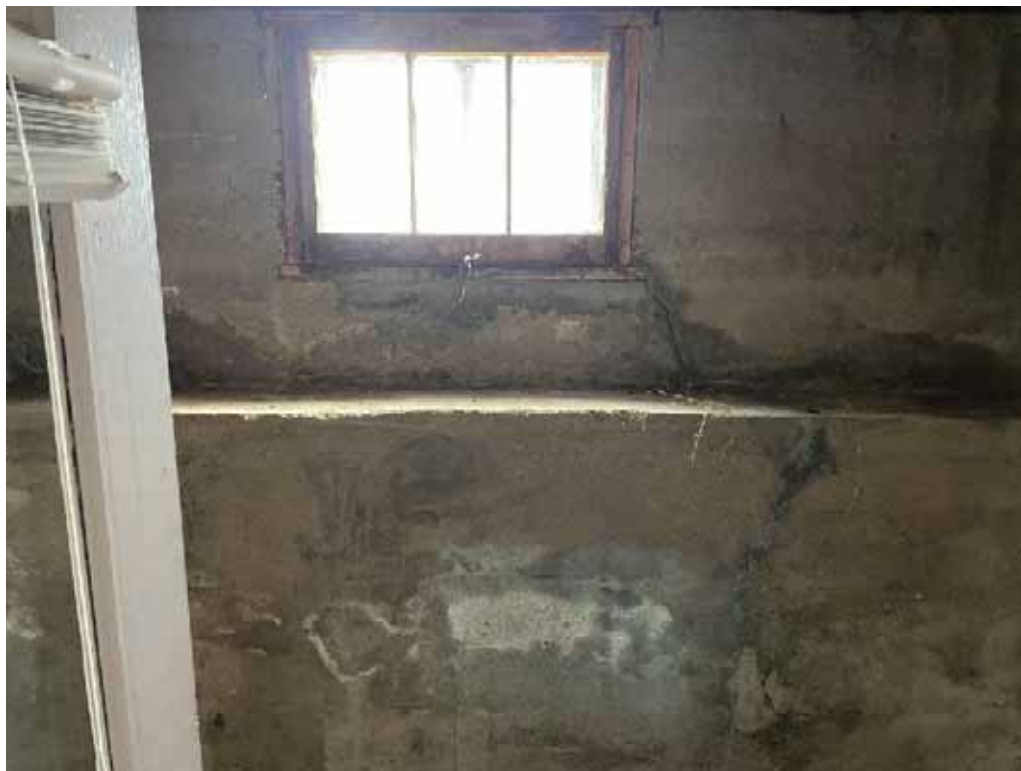
Figure 8: Shrinkage crack in east basement wall under porch

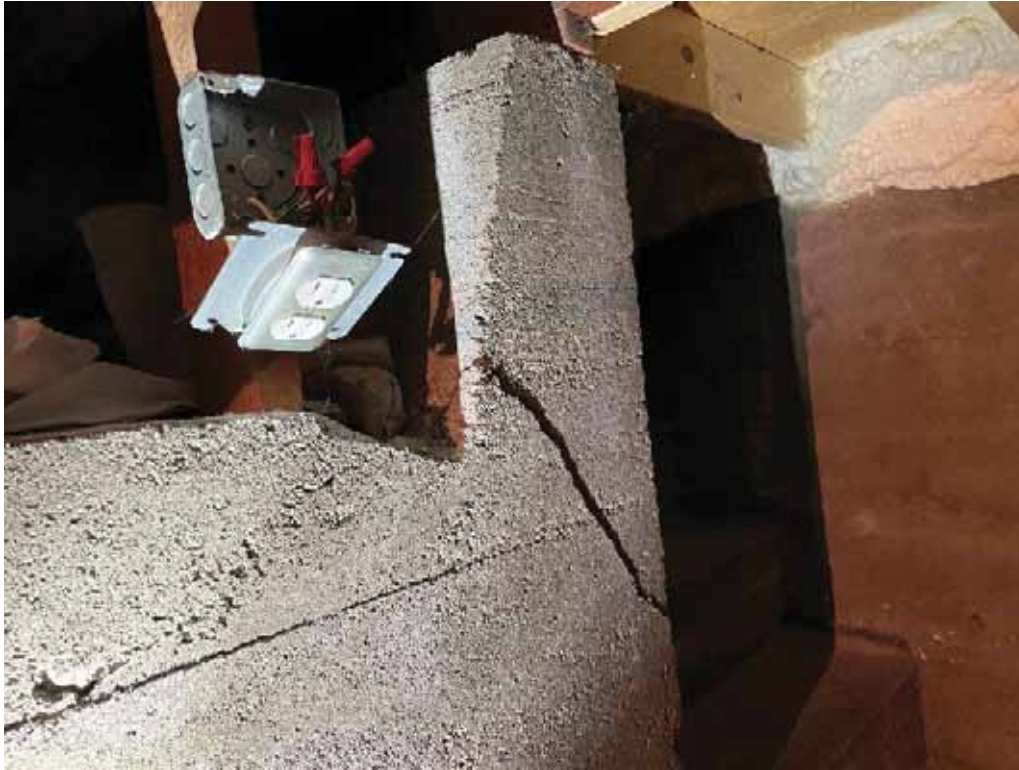
Figure 9: Presumed settlement crack at unused basement stair west side

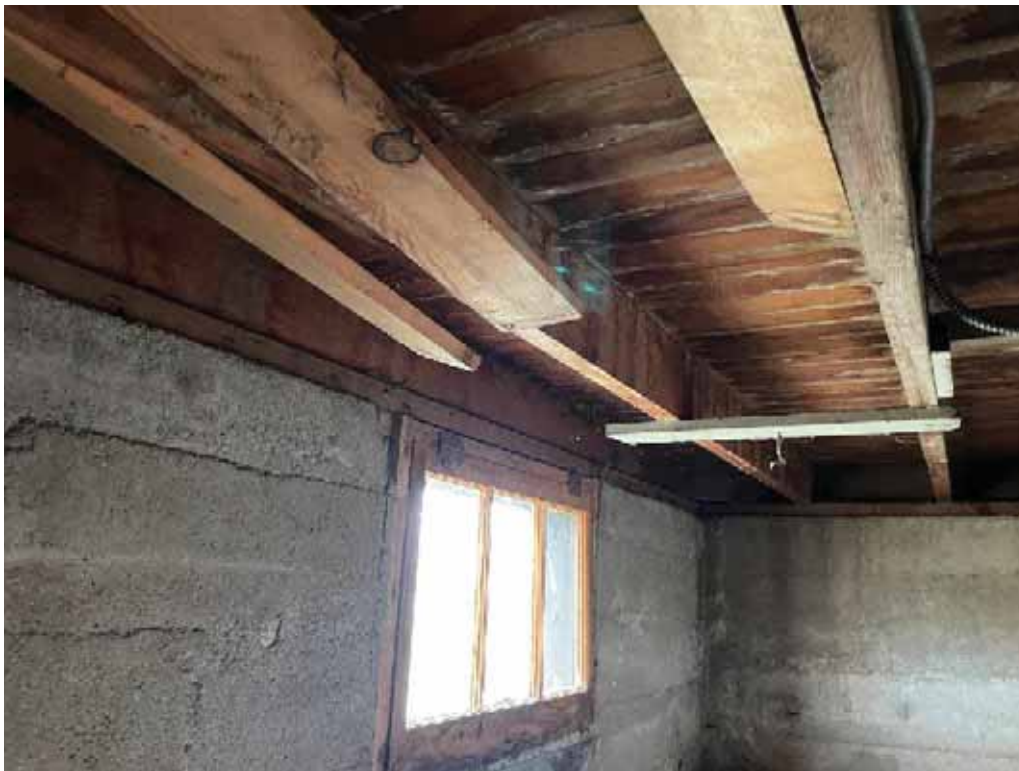
Figure 10: Water staining at porch framing

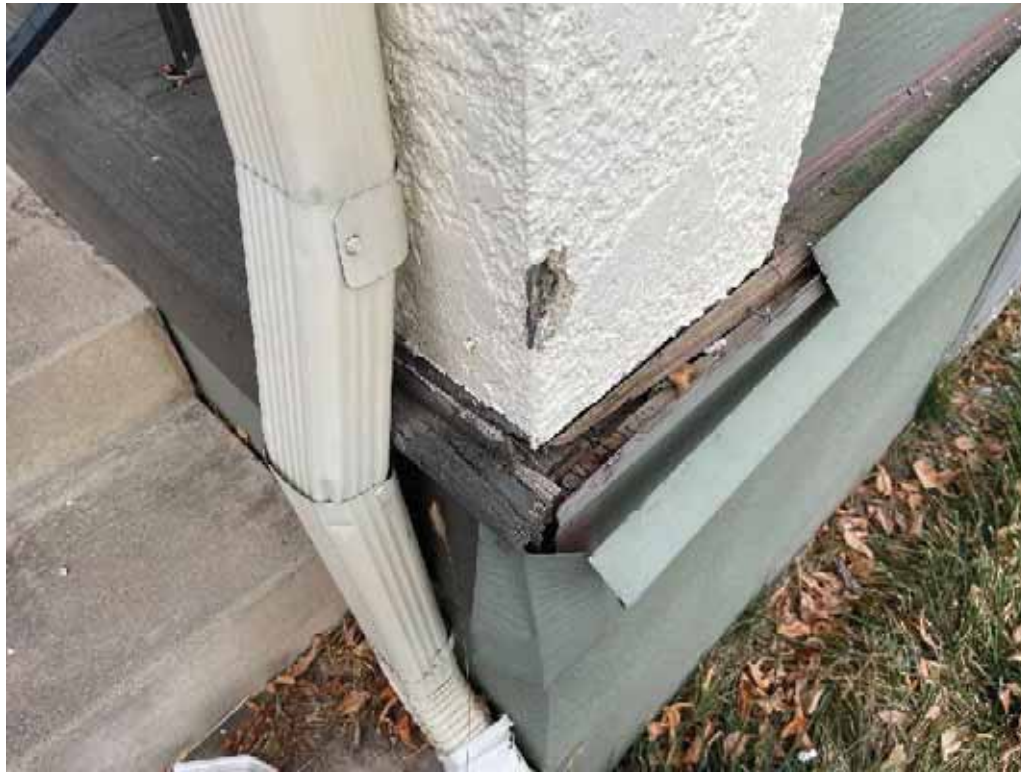
Figure 11: Deterioration at southeast corner of porch

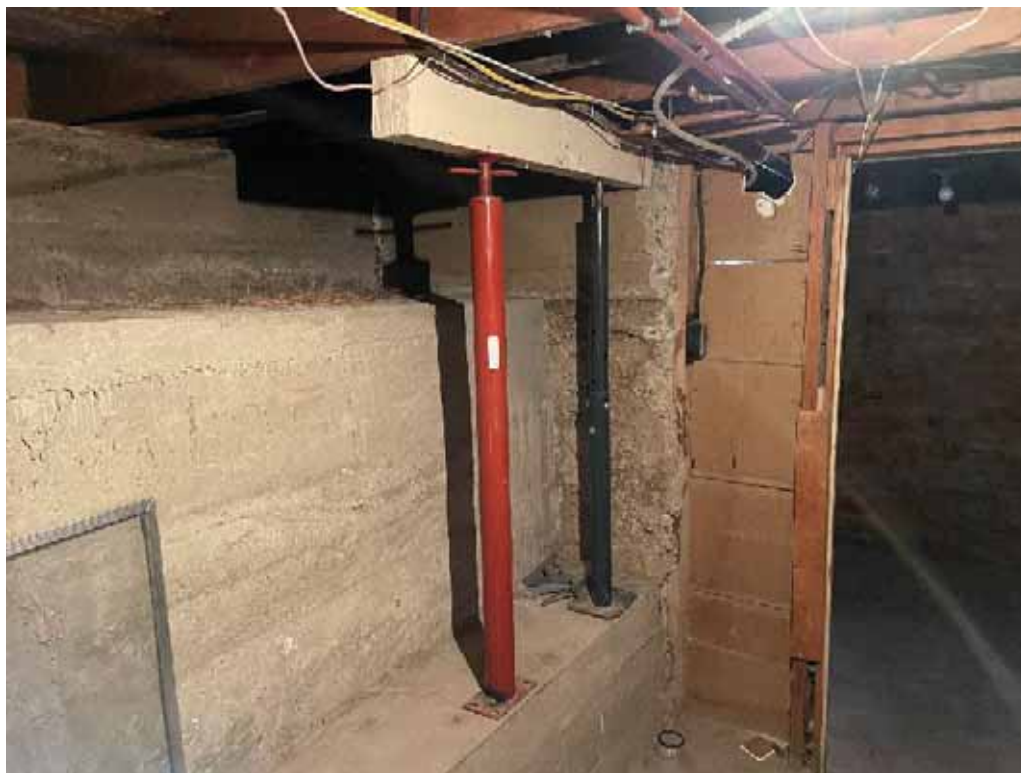
Figure 12: 4x6 dropped beam on jack posts in basement Room-9. Note that posts are not anchored, just friction-fit

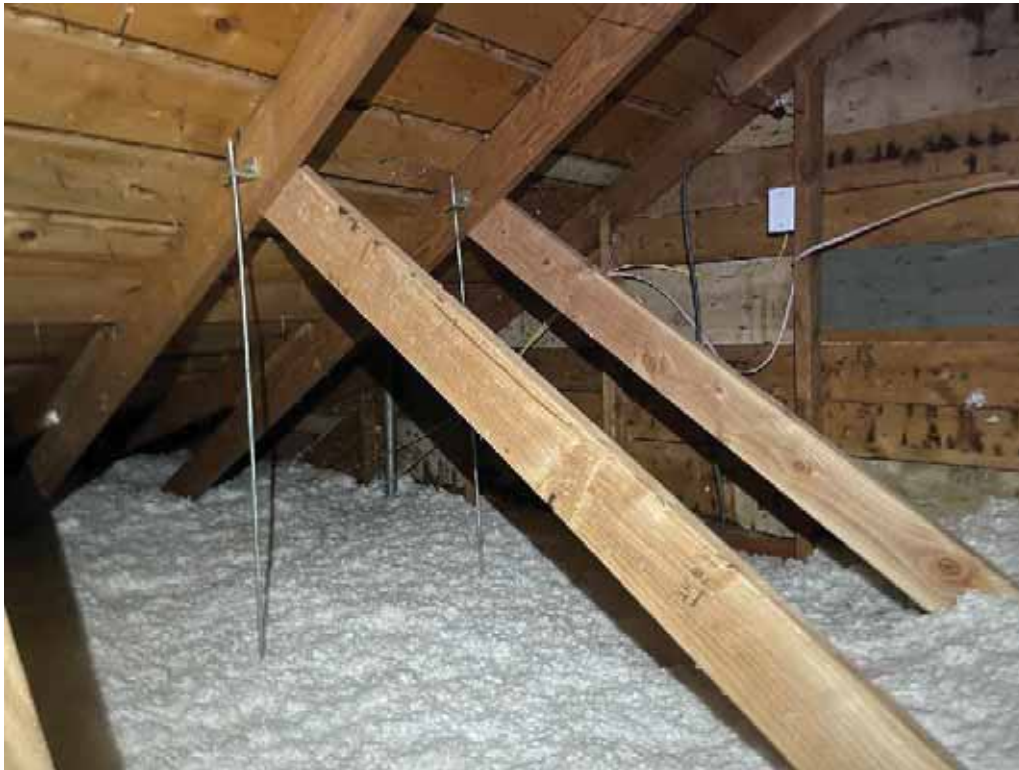
Figure 13: Roof framing with diagonal bracing and tie rod retrofit

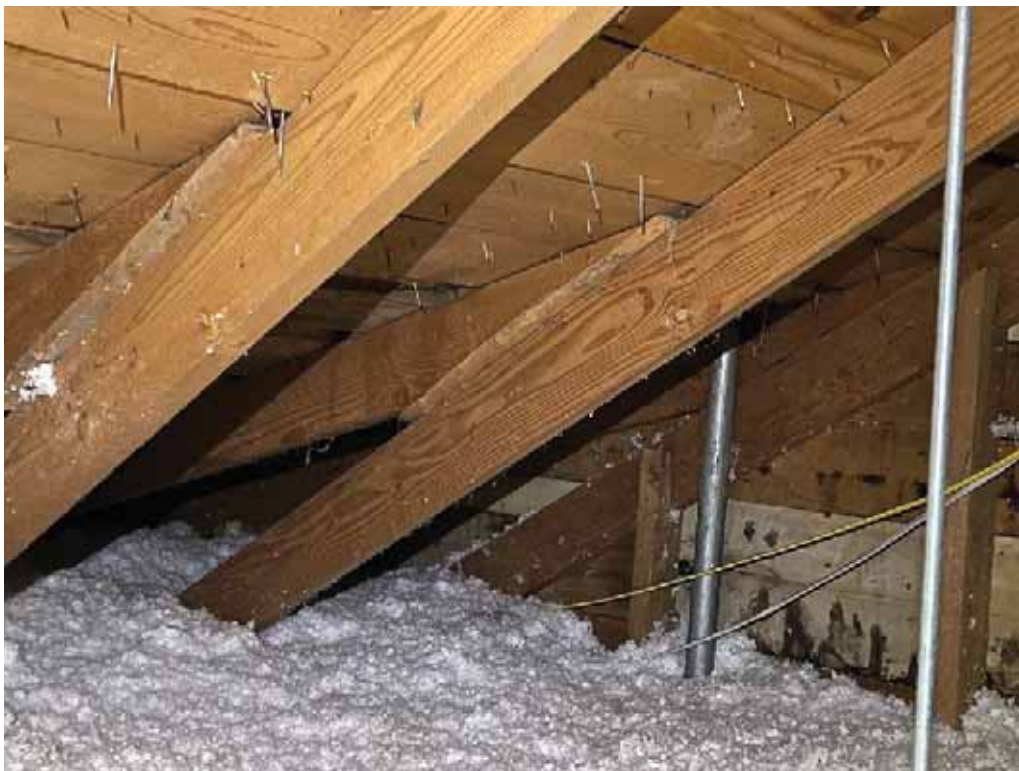
Figure 14: Typical shed rafter to main roof rafter connection. No connectors visible.

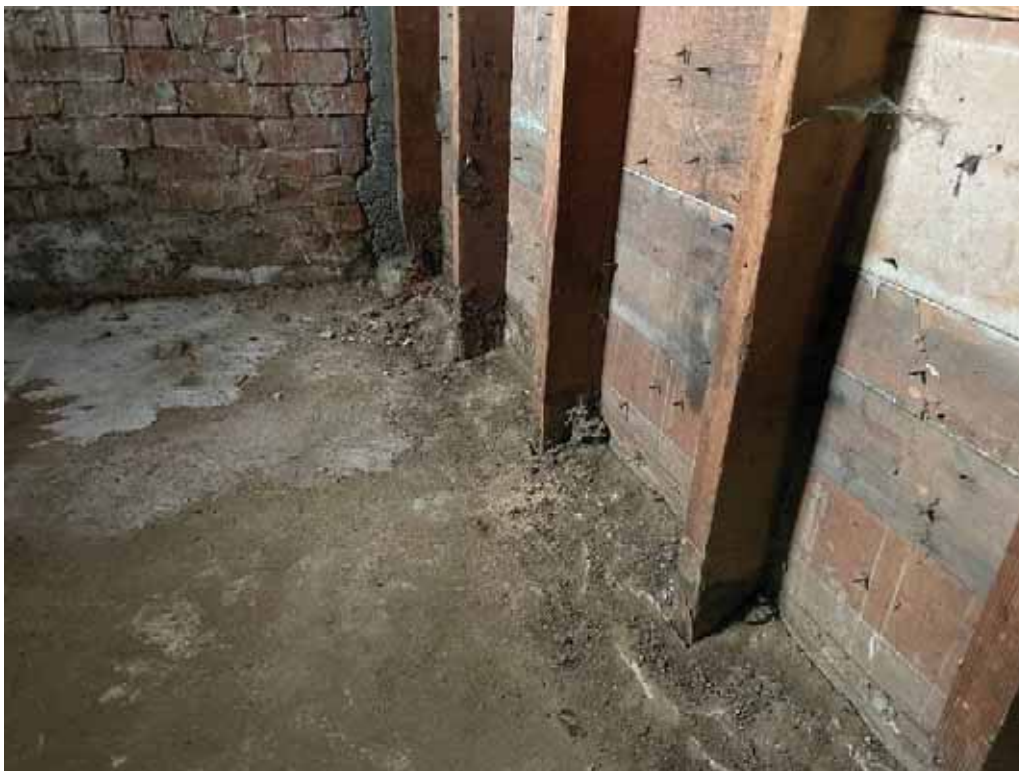
Figure 16: Deteriorated studs in basement Room-4

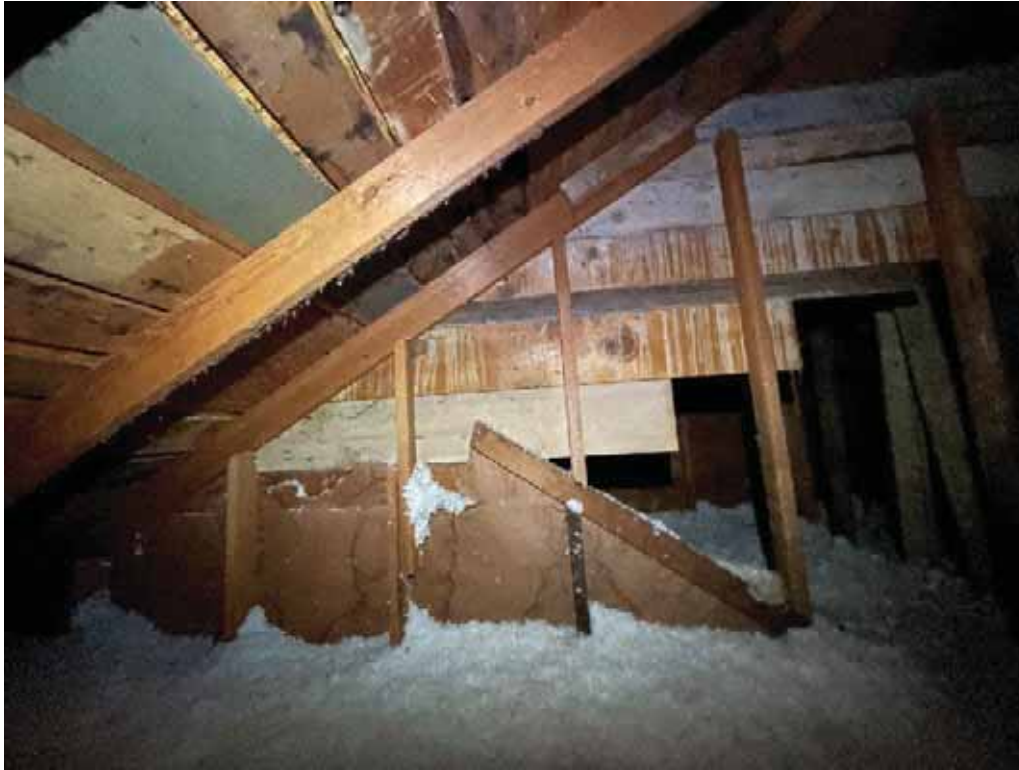
Figure 17: Discontinuous studs in east gable end wall

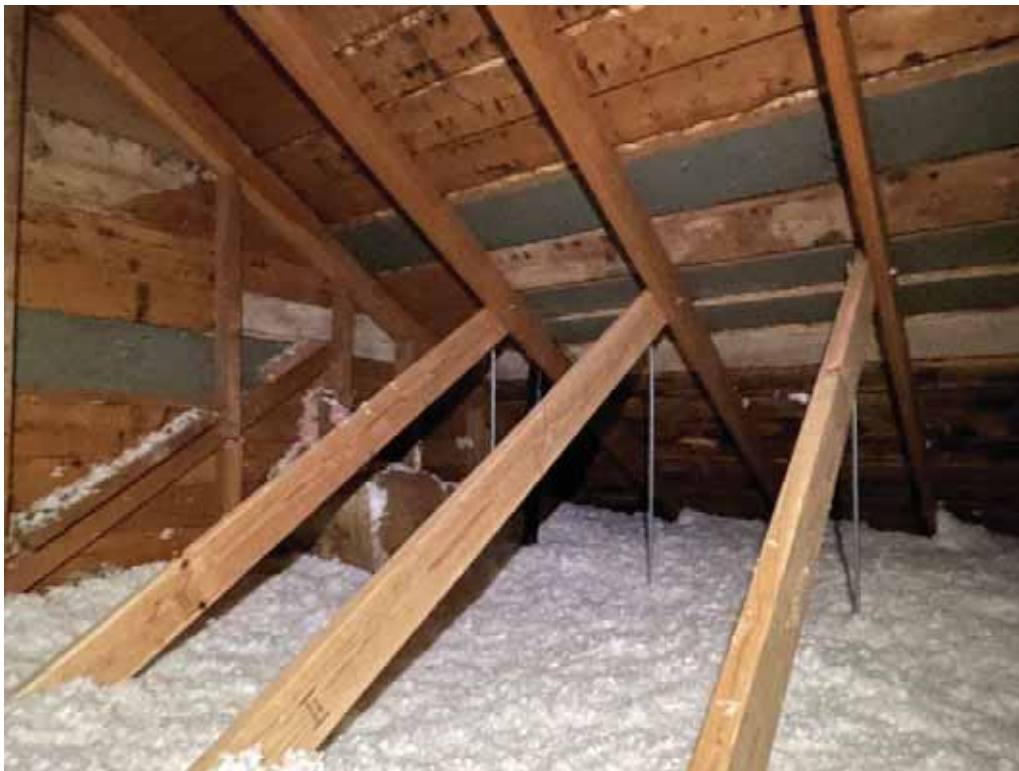
Figure 18: Discontinuous studs in west gable end wall

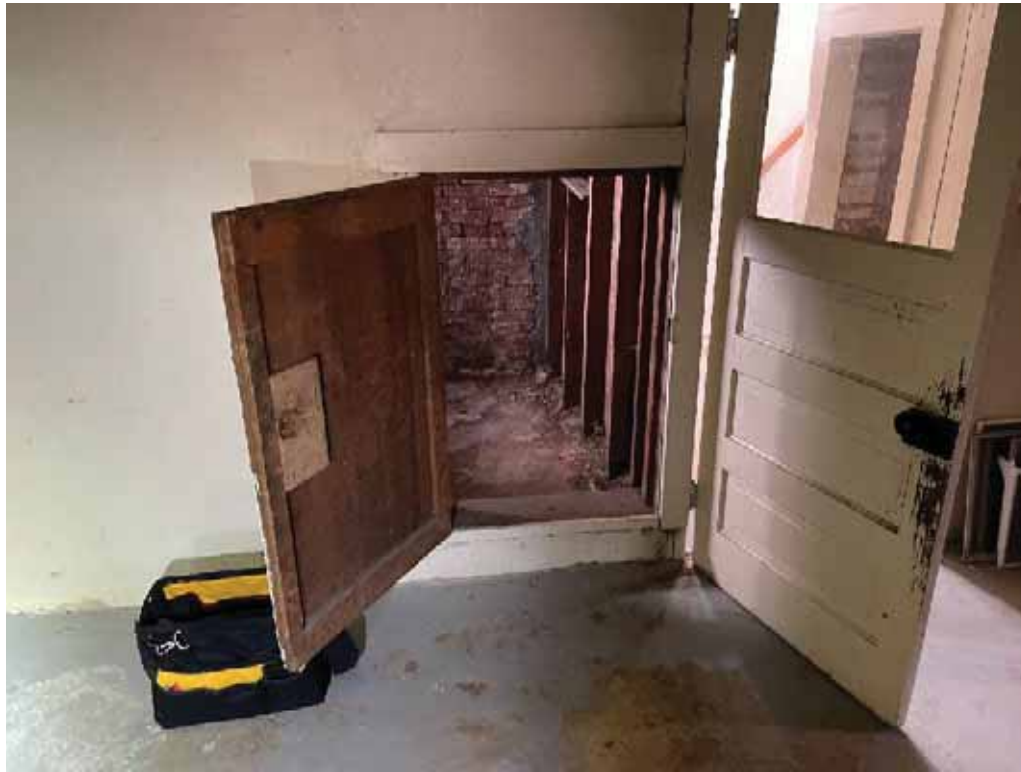
Figure 19: Little to no support for basement wall head at west side of opening into basement Room-4
