**SUBJECT:** RESOLUTION NO. 26, SERIES 2023 – A RESOLUTION  
APPROVING A PRESERVATION AND RESTORATION GRANT  
FOR THE A & L PORTA HOUSE AT 928 LA FARGE AVENUE

**DATE:** MAY 21, 2024

## RE: 928 LAFARGE LANDMARK DESIGNATION REQUEST & SIDING REPLACEMENT

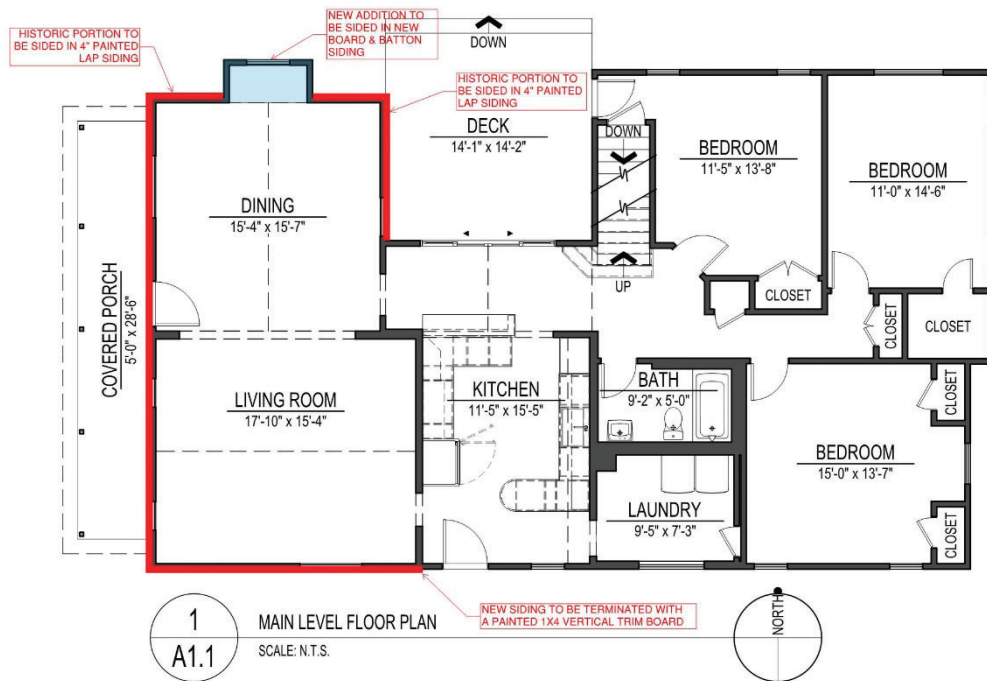
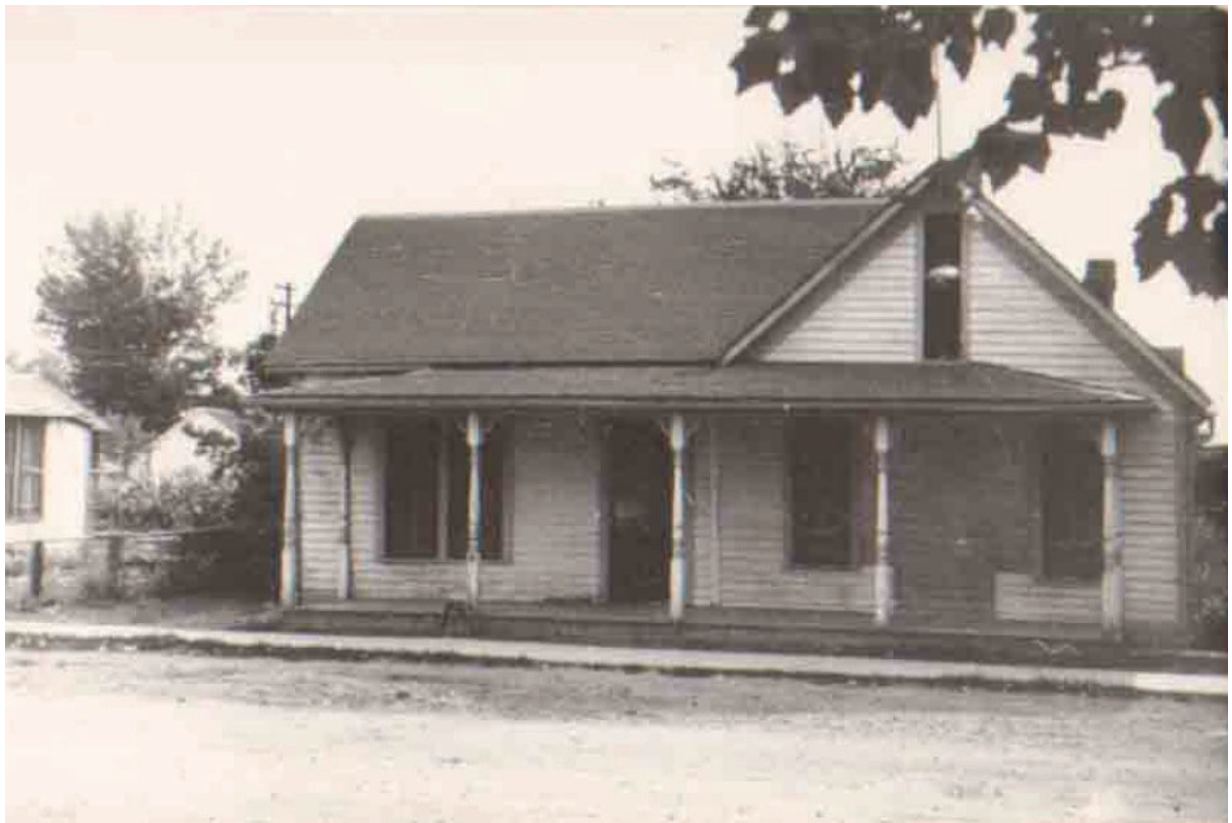
1950'S PHOTO

The 1950's photo shows the historic lap siding that has since been removed. Lap siding was the common siding for this era house and in particular for this portion of Lafarge Ave.

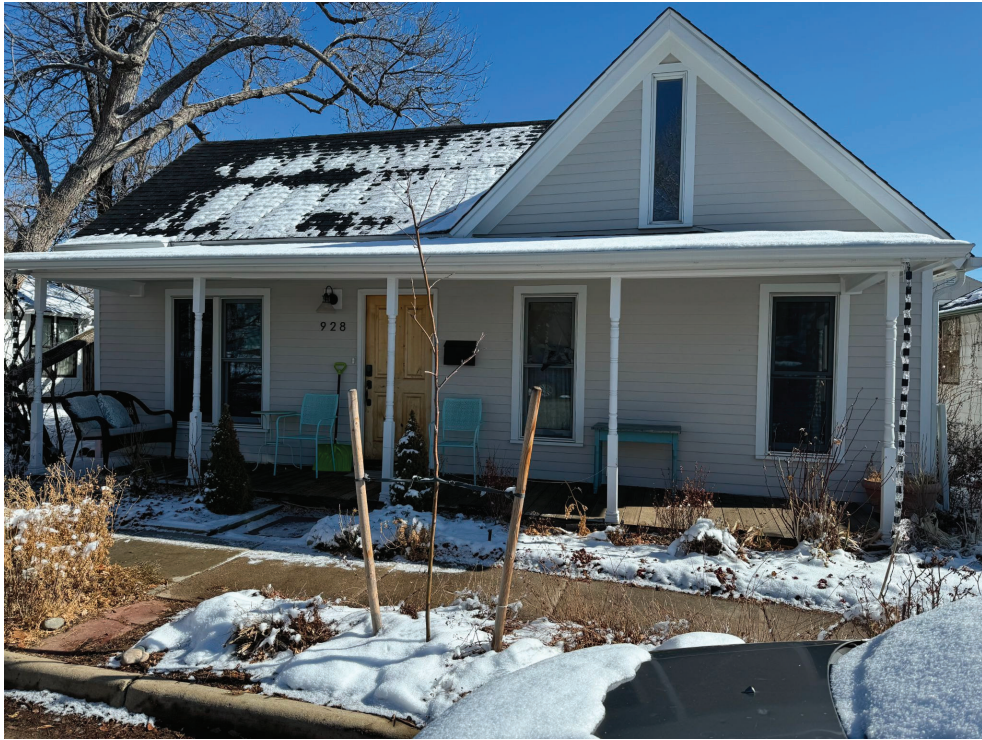
Restoration of siding on the historic part of the house, built in 1890.

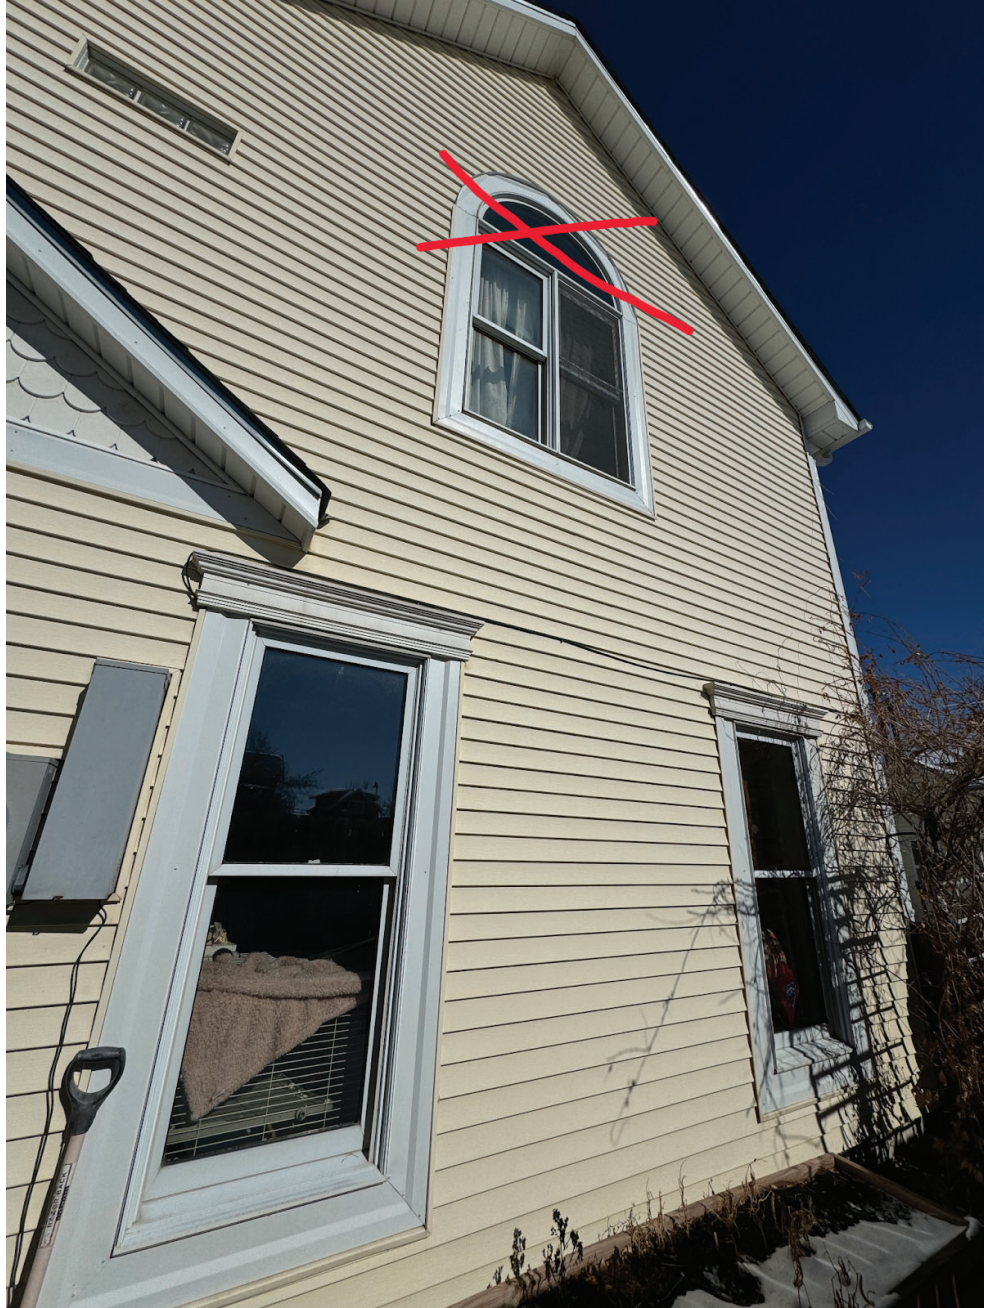
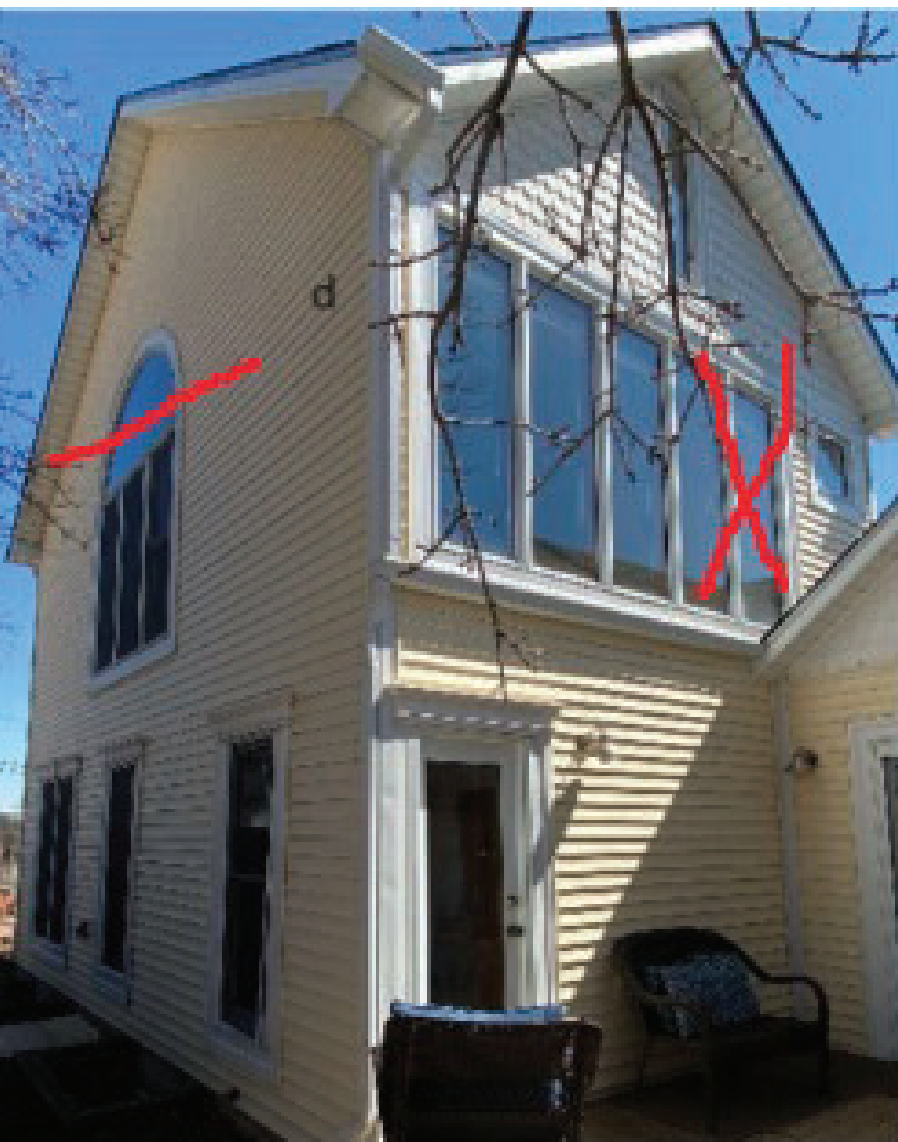
South side of non-historic part of the house - not part of the grant request.

half-circle window to be replaced with a transom window.

Row of windows to change to have 3 windows across, not 5.

Remove half-circle window. Replace with 2 taller double hung windows.

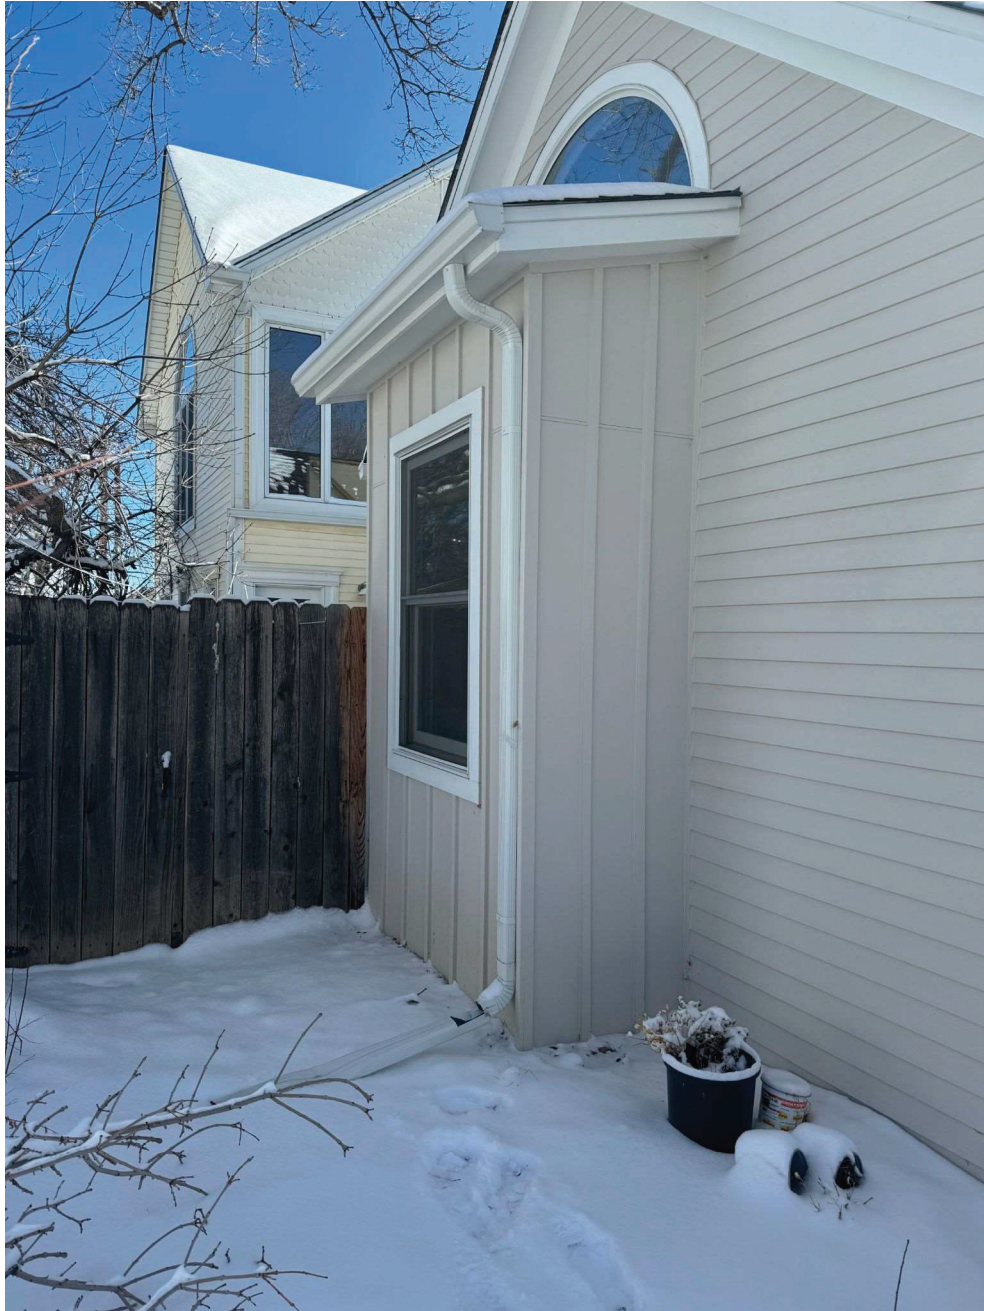
North side with bay window. The bay window was added on to the historic part of the house with the half-circular window above. It was decided with DAJ Design to side this section with board and batten siding to distinguish it from the historic part of the house.

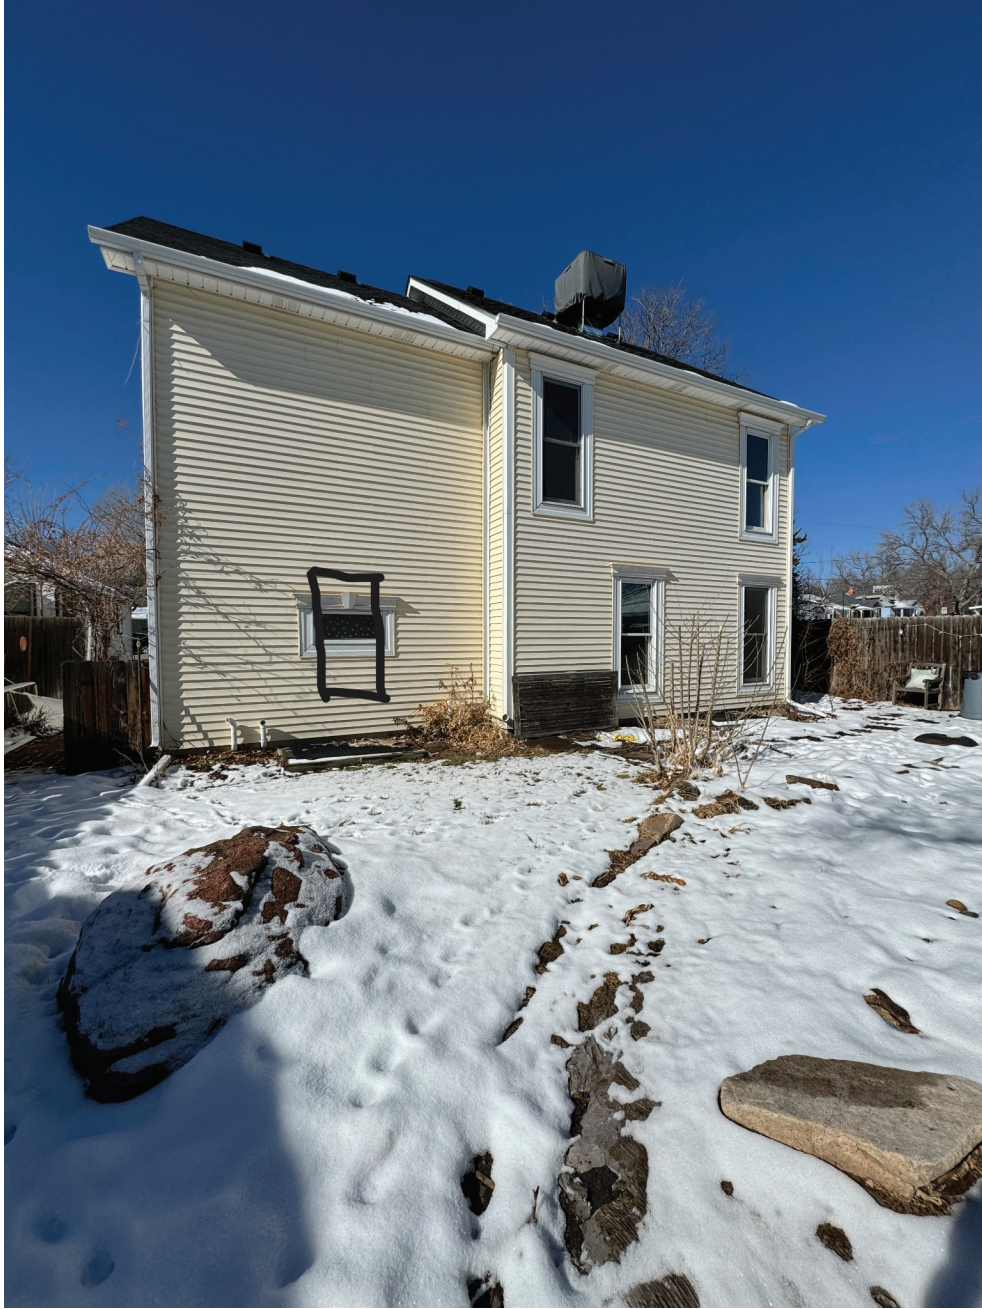
East side of non-historic part of the house - not part of the grant request.

Remove small window. Replace with taller double hung window, same size as other windows in the photo that are on the first floor.

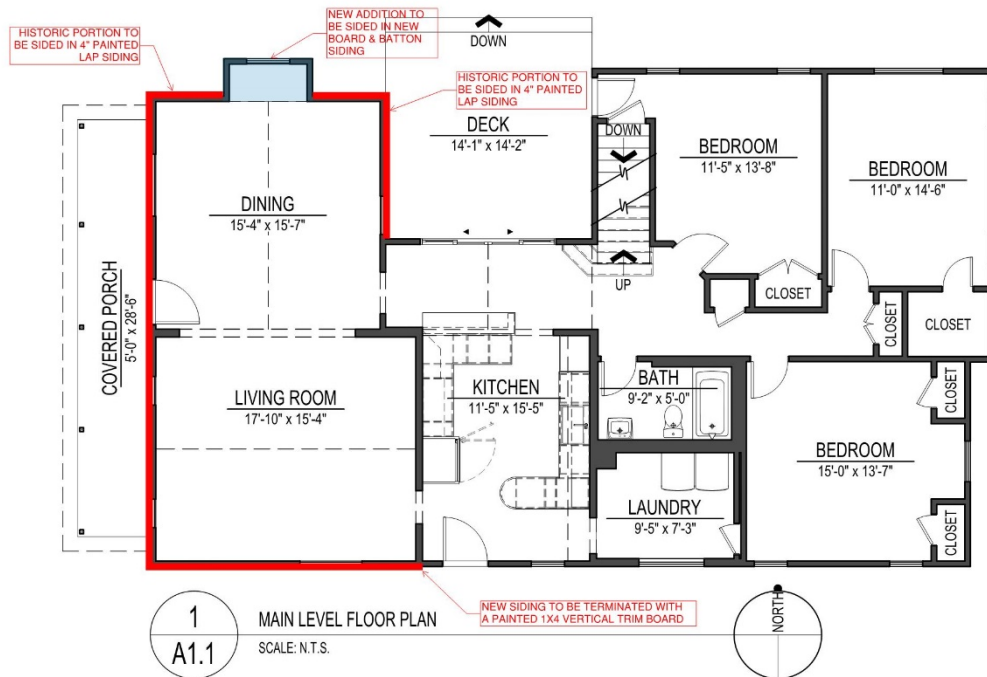
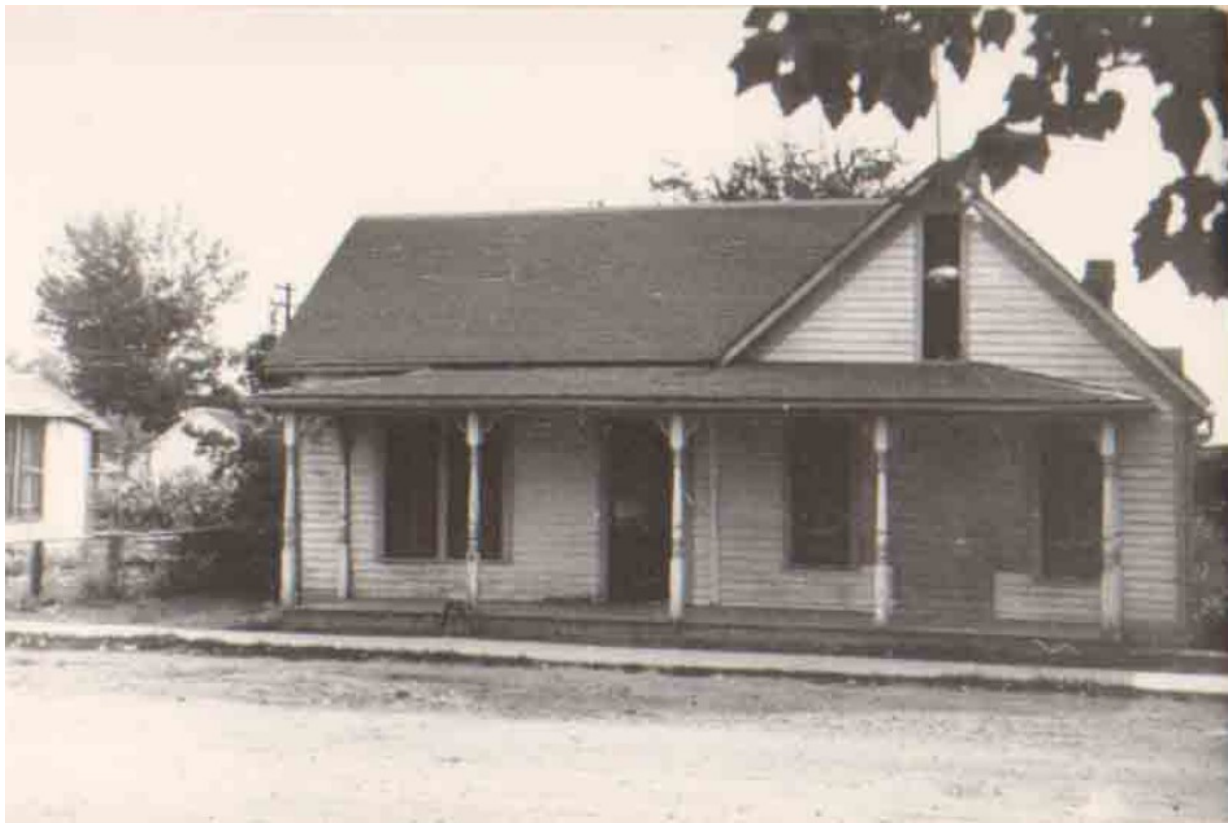
1950'S PHOTO

The 1950's photo shows the historic lap siding that has since been removed. Lap siding was the common siding for this era house and in particular for this portion of Lafarge Ave.

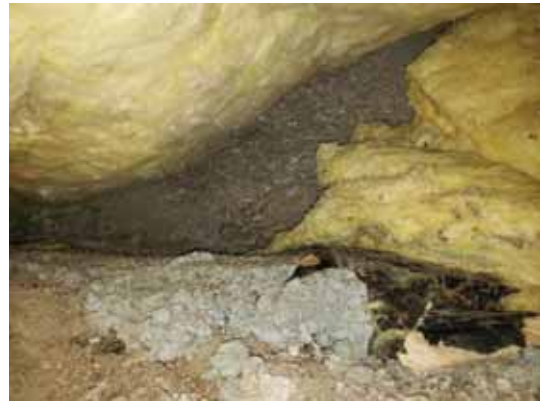
The portion of the house built prior to 1995 is built over a crawlspace less than two feet deep with a central area dug down approximately four feet or more that provides limited access. This crawlspace area is accessed on the east side from a full-depth basement below the 1995 addition. The crawlspace has a vapor barrier throughout, and the foundation walls are covered with a fiberglass insulation. The insulation was pulled away in a few locations to reveal a shallow concrete foundation with a concrete footing. It appears that this type of foundation wall encompasses the entire portion of the house built prior to 1995. It is unclear if the concrete was poured over an original foundation of either stacked stone or brick or the original foundation may have been replaced by the existing concrete. The foundation under the original house could not be determined from the exterior as siding runs to grade. Due to the insulation covering the foundation walls in this area, it is impossible to determine how the floor joists bear on the foundation and whether or not a sill plate exists.

*Crawlspace foundation with insulation pulled back*

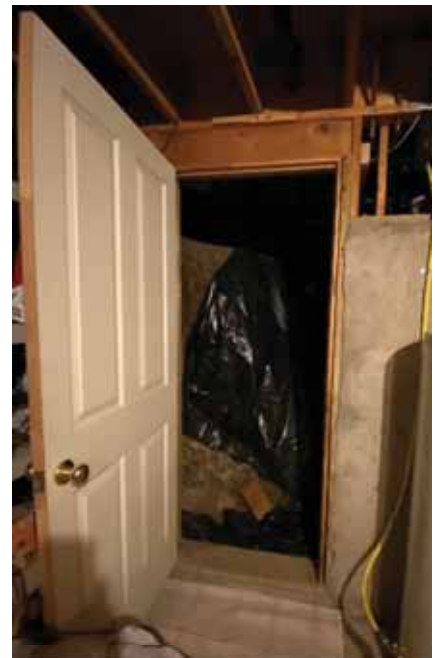
4. The basement wall between the crawl space and mechanical room should have been designed for retaining the crawl space soil. The basement wall footing should be further investigated by a licensed structural engineer and geotechnical engineer prior to any remodel work completed at the house.

5. The excavation completed during the 1995 addition undermined isolated footings in the crawl space. The soil should be evaluated by a geotechnical engineer and repaired as necessary. Repairs should be coordinated with a licensed structural engineer.

*Separation between basement & crawlspace in mechanical room. Poured concrete wall with cinder block above on the right*

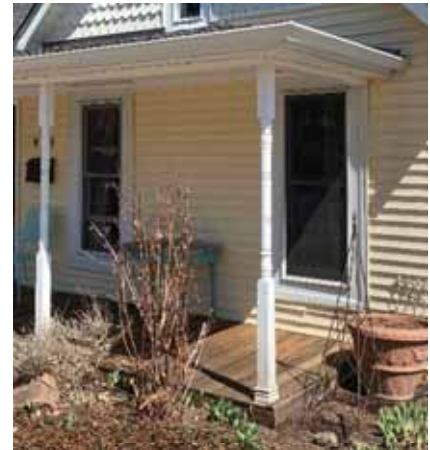
A covered front porch exists on the western elevation, spanning almost the entire width of the house. This porch is visible in the 1948 Boulder County Assessor card image and is nearly identical to the current appearance. The front porch is five feet deep and 28 ½ feet wide, centered on the west elevation. The porch was likely added or expanded during the first house addition. The porch deck is wood framed on grade with wood decking that sits slightly lower than the finished floor and is raised only a couple of inches above grade. The porch is covered with a hipped roof supported by five turned wood columns, nearly equally spaced. Historical images show three attached columns that no longer exist. According to building records, the front porch was repaired and the columns were replaced in 1995. At some point, likely during the 1995 restoration, column brackets were removed that are visible in historic photographs.

*Covered front porch*

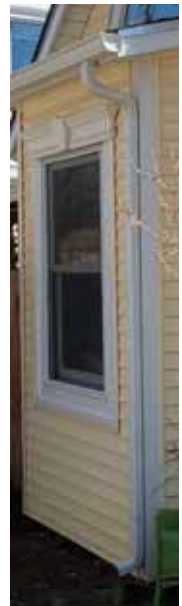
*Typical gutter & downspout without an extension*

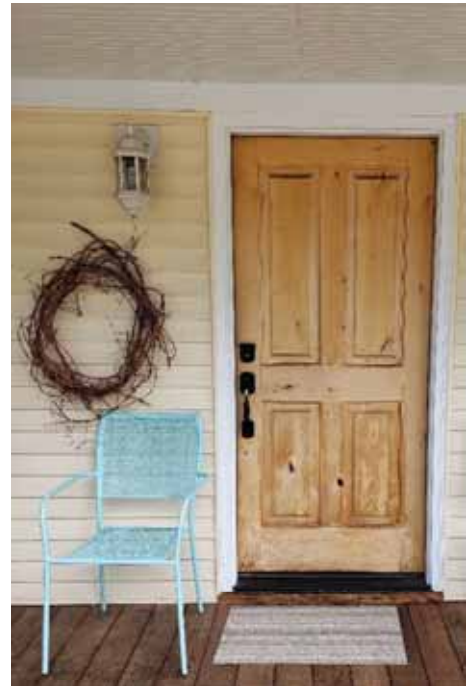
*Front door*

Replace the front door with a stained wood door similar to the original style of the house. There are several examples of front doors throughout the Louisville area that should be used as guidance.

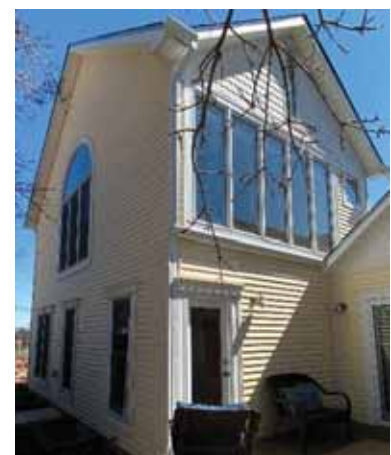
*North & west side windows*

Remove the north side bay window and transom window above the bay. It is possible that there may have been a window on this side of the original structure but there is no photographic evidence, and any structural evidence was likely lost with the addition of the bay. If evidence of a window is found during removal of the bay and siding, a window matching the sizes and styles of the other original windows should be added at this location.
