**SUBJECT:** RESOLUTION NO. 30, SERIES 2023 – A RESOLUTION APPROVING A PRESERVATION AND RESTORATION GRANT FOR THE COLACCI HOUSE AT 1209 MAIN STREET

# 1209 Main Street

## Historic Structure Assessment

#### 3.0 Condition Assessment

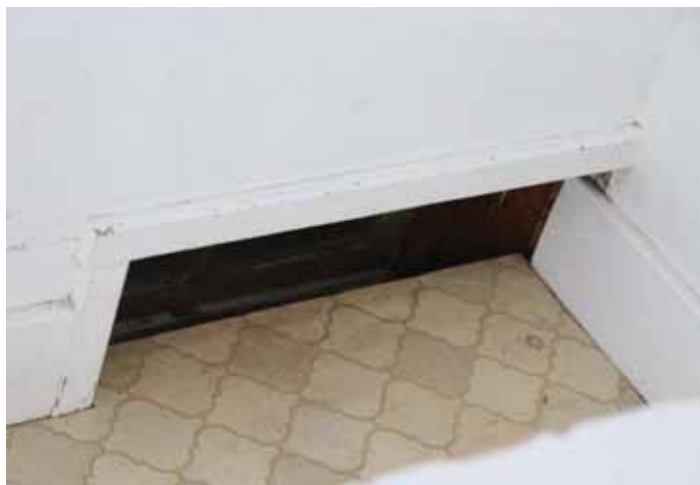
- An exterior basement window obstructed by the current stairs to the basement. The stairs to the basement are within the south side shed roof protruding portion of the building

Image 3: Basement window is bisected by the main level landing to the basement stairs

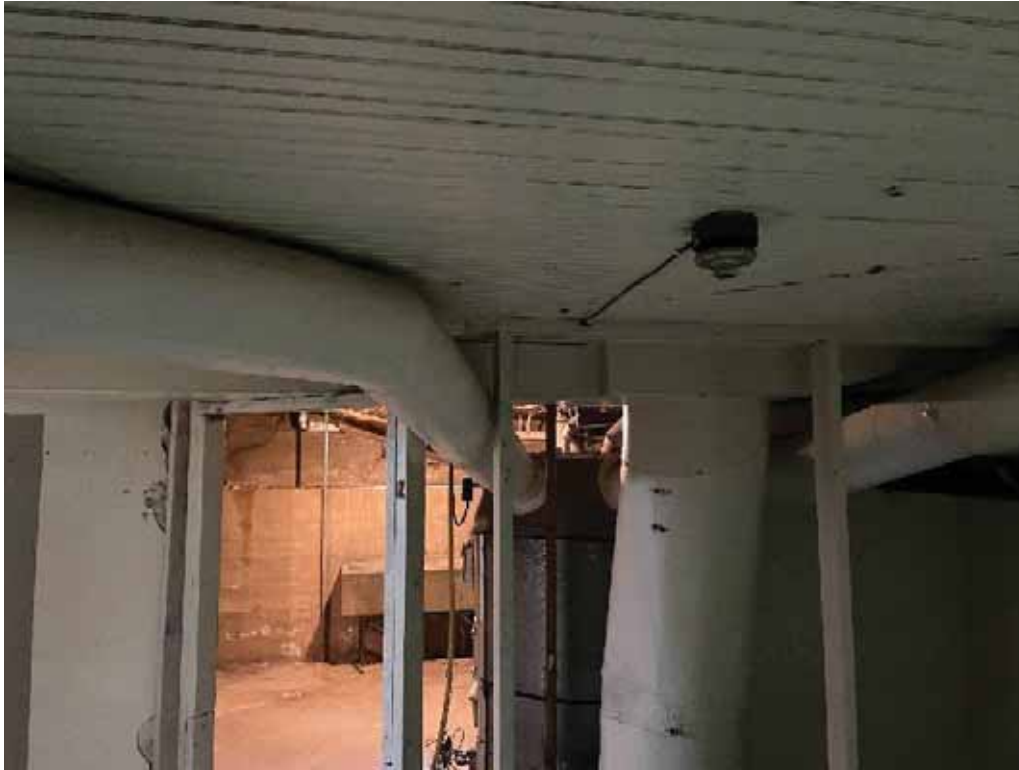
Figure 15: Stud wall at basement Room-2 supporting 2x8 floor joists with opening in concrete wall beyond
