**SUBJECT:** RESOLUTION NO. 30, SERIES 2023 – A RESOLUTION APPROVING A PRESERVATION AND RESTORATION GRANT FOR THE COLACCI HOUSE AT 1209 MAIN STREET

# 1209 Main Street

## Historic Structure Assessment

#### 3.0 Condition Assessment

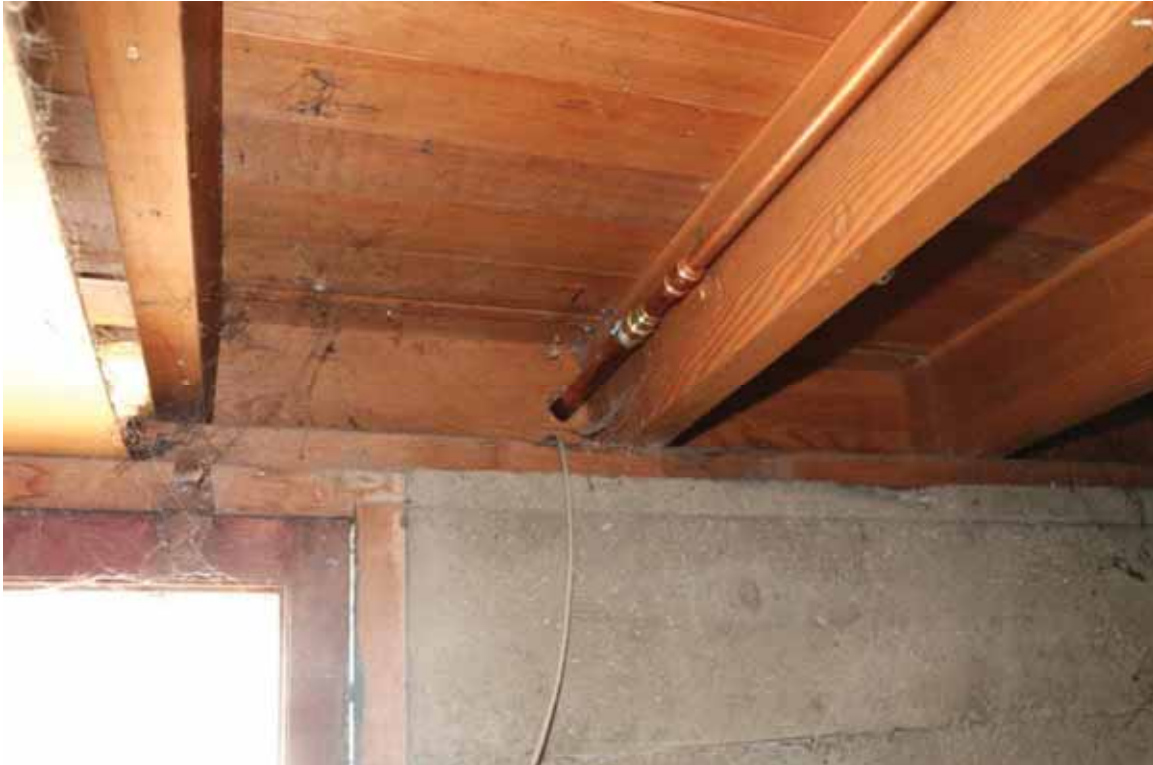
Image 13: Floor & Ceiling Systems\_ 2x6 wood joists with sill plates resting on concrete foundation walls

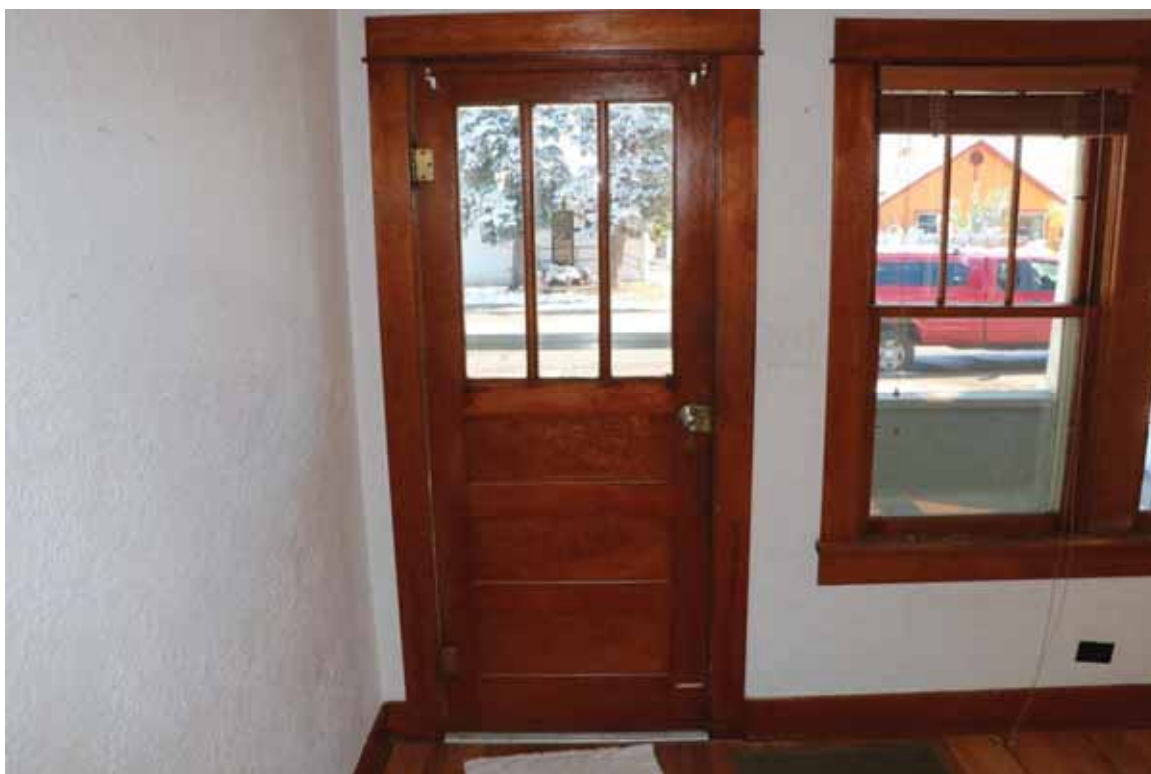
| Element | Description & Condition | Evaluation | Recommendation |
|---|---|---|---|
| Doors (including Hardware, Casing/Trim, and Finishes) | <p>Front door matches windows and is likely original. Door is stained and varnished wood and features three vertical lites above with three horizontal panels below.</p> <p>Bedroom doors are two-panel stained and varnished wood. They appear to be original</p> <p>Interior door to the south side shed roof protrusion is 15-lite, stained and varnished wood.</p> <p>Exterior door on the south elevation is four-panel with large single-pane lite, painted wood.</p> <p>Doors are all two-hinge design, with only one set of knob hardware appearing to be original</p> <p>Interior casing appears to be original, and consists of stained and varnished wood, 4 1/8" wide side and top boards with a 1/2" cap at the door head</p> | Good | <p>Perform general maintenance. Inspect and repair weatherstripping on the exterior doors.</p> <p>Monitor crack in bottom panel of south-side exterior door.</p> |

Image 26: Doors\_Front door

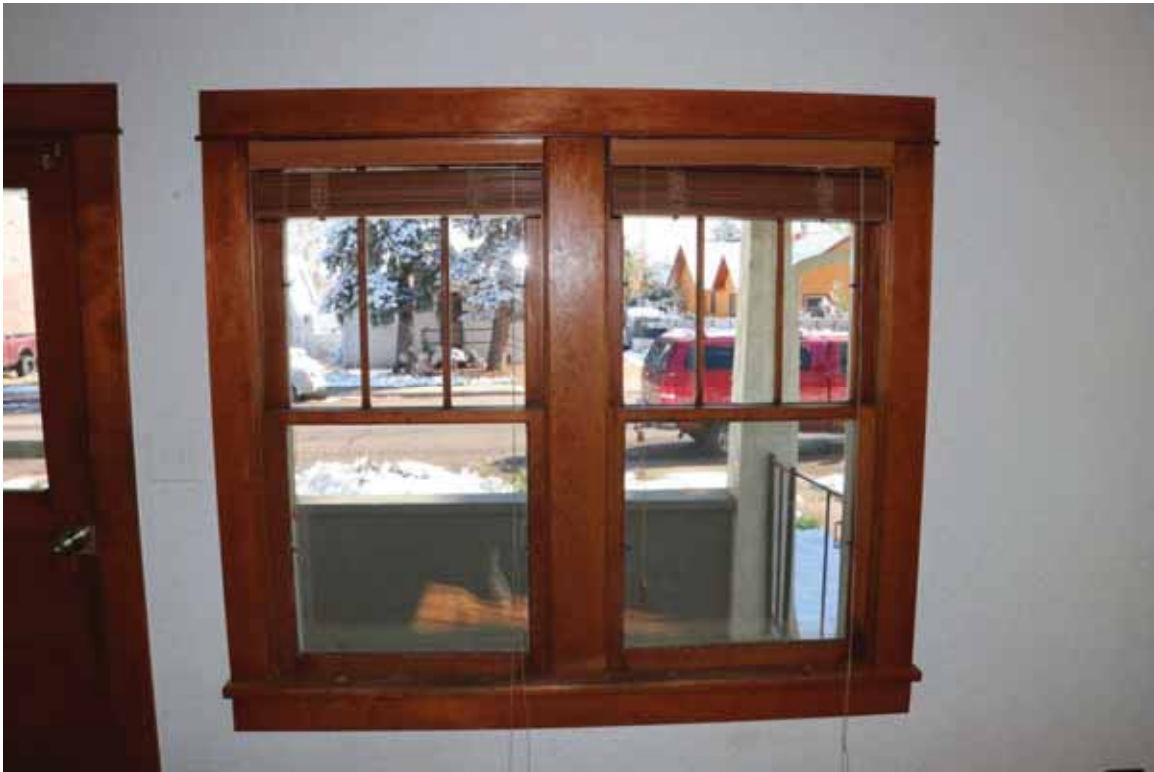
| Element | Description & Condition | Evaluation | Recommendation |
|---|---|---|---|
| Windows (including Hardware, Casing/Trim, and Finishes) | <p>Window casing matches the doors.</p> <p>Windows on the main level are three-over-one, wood, double-hung windows with spring-pin stays. The windows are stained and varnished except for the kitchen and dinette windows, which are painted. The kitchen windows have been modified with tape balances.</p> <p>The windows are all in good condition, with no repairs needed that would be outside of a general maintenance scope.</p> <p>There are storm windows on the exterior</p> <p>Basement windows are a variety of types, including replacement windows. The oldest surviving style is the three-lite wood awning-style windows in fair condition</p> | <p>Good-<br/>Main level</p> <p>Fair-<br/>Basement</p> | <p>Main level: Perform general maintenance. Paint and glazing putty touchups. Lubricate spring pins.</p> <p>Basement: Clear debris from exterior. Ensure positive drainage away from building. Windows would require a level 2 restoration per the National Park Service Preservation Brief 9.</p> |

Image 28: Windows\_ Representative windows

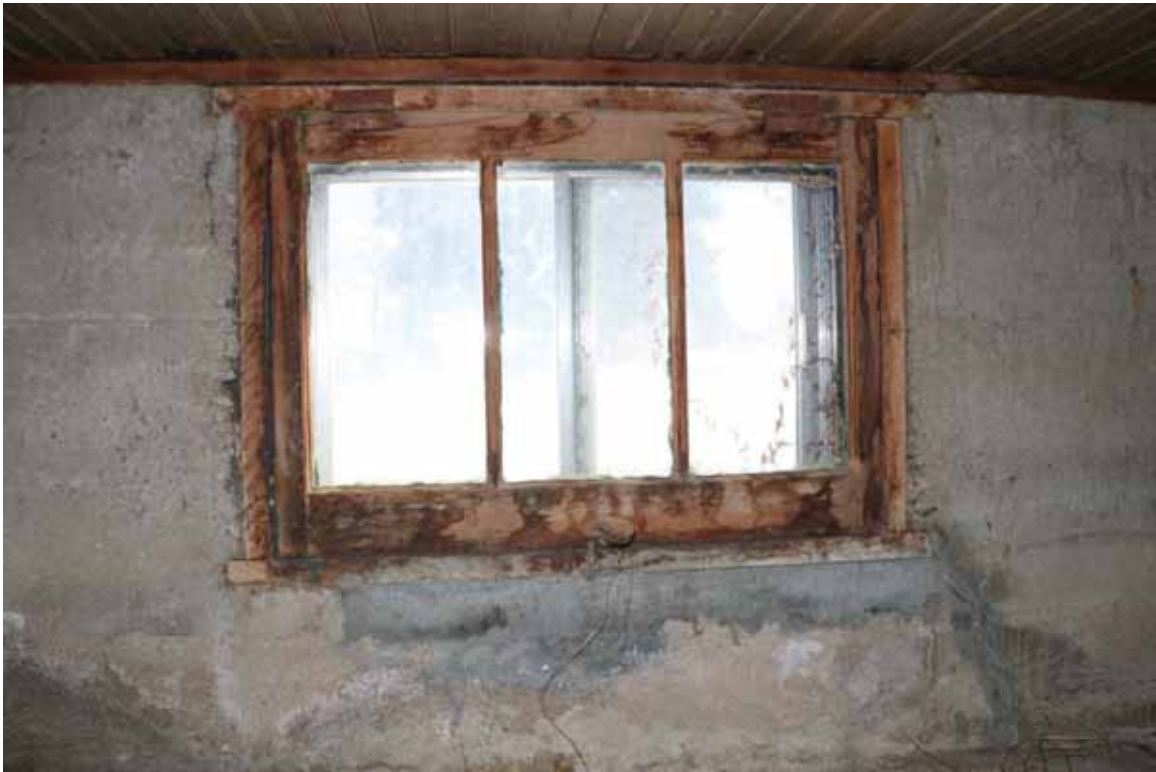
Image 30: Windows\_ Representative historic basement window

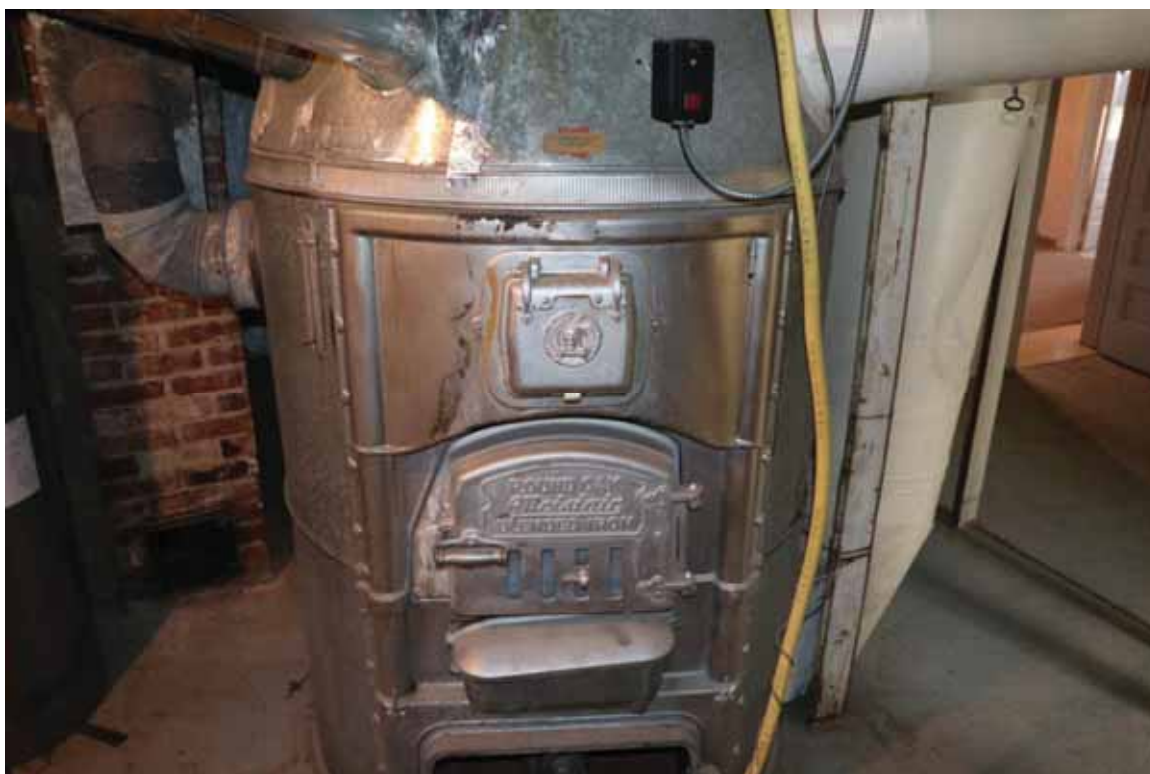
Image 35: Heating & Air-Conditioning\_ Round Oak Furnace

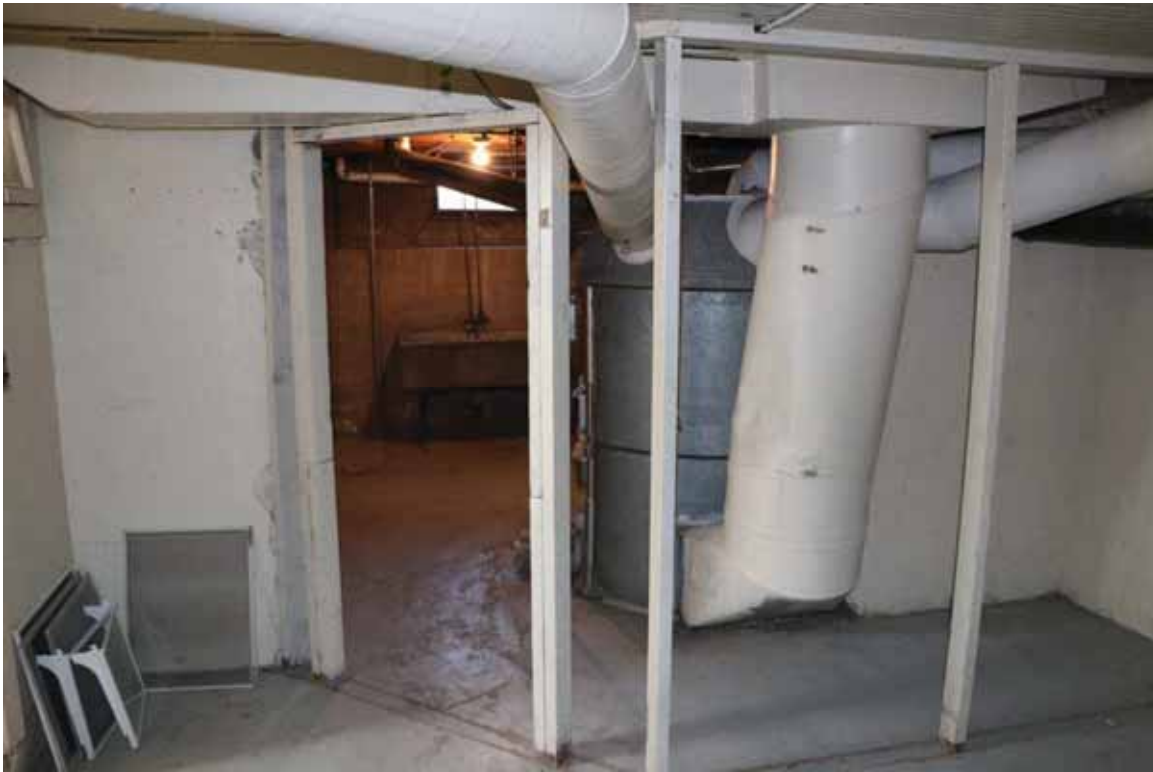
Image 37: Heating & Air-Conditioning\_ Furnace ducting, return air at the bottom and distribution ducting at the top

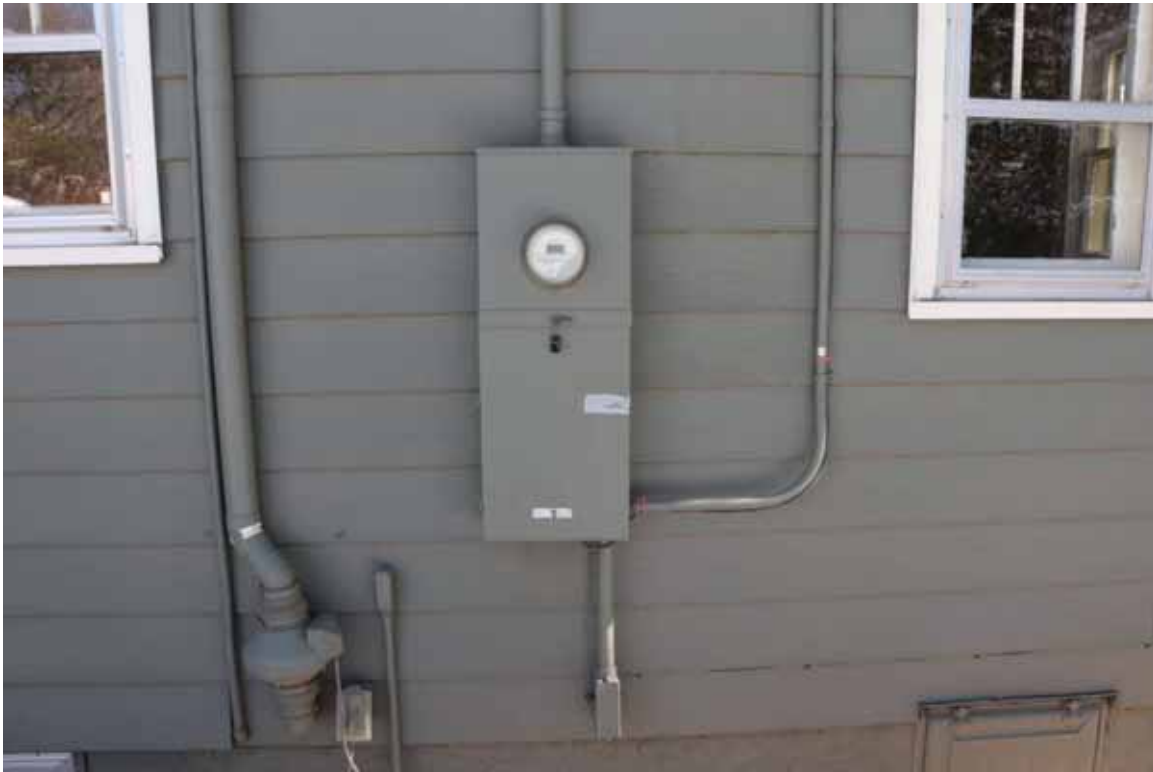
Image 39: Electrical Service & Panels\_ Connection at rear of home
